Contract #: 04-0120F4Cty: SF/ALA Rte: 80 PM: 13.2/13.9File #: 69.28**WELDING INSPECTION REPORT****Resident Engineer:** Pursell, Gary**Address:** 333 Burma Road**City:** Oakland, CA 94607**Report No:** WIR-003874**Date Inspected:** 08-Aug-2008**Project Name:** SAS Superstructure**OSM Arrival Time:** 700**Prime Contractor:** American Bridge/Fluor Enterprises, a JV**OSM Departure Time:** 1530**Contractor:** Zhenhua Port Machinery Company, Ltd (ZPMC), Changxing Island **Location:** Shanghai, China**CWI Name:** Sun Wei, Guo Yan Fei**CWI Present:** Yes No**Inspected CWI report:** Yes No N/A**Rod Oven in Use:** Yes No N/A**Electrode to specification:** Yes No N/A**Weld Procedures Followed:** Yes No N/A**Qualified Welders:** Yes No N/A**Verified Joint Fit-up:** Yes No N/A**Approved Drawings:** Yes No N/A**Approved WPS:** Yes No N/A**Delayed / Cancelled:** Yes No N/A**Bridge No:** 34-0006**Component:** Tower & OBG**Summary of Items Observed:**

WELDING INSPECTION REPORT

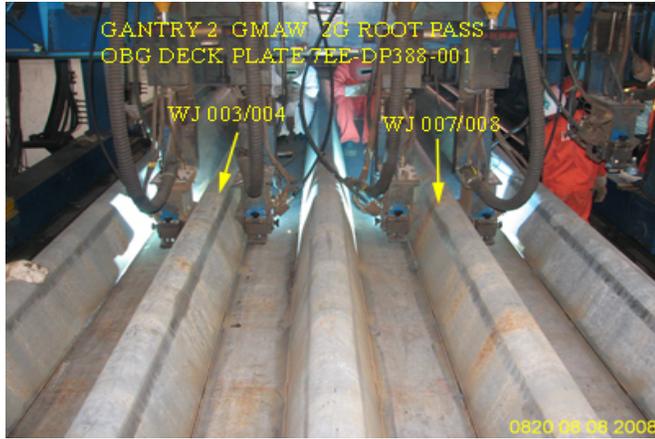
The QA Inspector randomly observed ZPMC welders Xu Guo Yin ID Number 059443, Xiang Huan Feng ID Number 059416, Chen Jie ID Number 059468 and Xiang Jie ID Number 059378, utilizing Gantry 2 mounted welding apparatus with the Gas Metal Arc Welding (GMAW) Process in the 2G (Horizontal Groove) Position with ZPMC Weld Procedure Specification (WPS) WPS-B-T-2342-U1(U-Rib)-4, to weld the root pass of the U-Ribs to 4-Rib Deck Plate Sub-Assembly 7EE-DP388-001 at Weld Joint (WJ) Numbers DP388-001-003/004 and 007/008. The QA Inspector randomly observed ZPMC QC monitoring weld parameters. The QA Inspector also randomly monitored weld parameters and recorded them as follows: 378/372 amps, 30.4/30.6 volts (WJ's 003/004) for Mr. Xu/Mr. Xiang; and 368/374 amps, 30.7/30.5 volts (WJ's 007/008) for Mr. Chen/Mr. Xiang with a travel speed of 525 millimeters (mm) per minute for all welders. The weld parameters appeared to comply with contract requirements. The attached photograph provides additional detail.

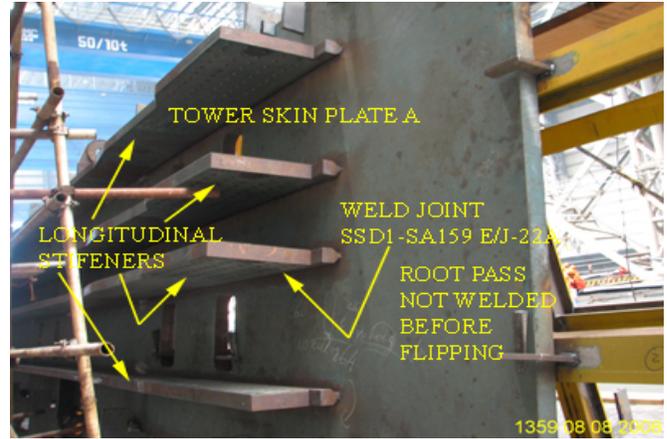
The QA Inspector randomly observed that CJP WJ SSD1-SA159E/J-22A of Tower Skin Plate A Sub-Assembly SSD1-SA159, did not have the root pass welded prior to flipping to B side for back gouging per approved ZPMC Procedure Sheet RP-03 - Welding the CJP Joint of Longitudinal Stiffeners. The attached photograph provides additional detail. The QA Inspector generated an Incident Report for this item for 08-08-08.
