**DEPARTMENT OF TRANSPORTATION**

Contract #: 04-0120F4Cty: SF/ALA Rte: 80 PM: 13.2/13.9File #: 69.28**WELDING INSPECTION REPORT****Resident Engineer:** Pursell, Gary**Address:** 333 Burma Road**City:** Oakland, CA 94607**Report No:** WIR-003888**Date Inspected:** 15-Sep-2008**Project Name:** SAS Superstructure**OSM Arrival Time:** 1430**Prime Contractor:** American Bridge/Fluor Enterprises, a JV**OSM Departure Time:** 2000**Contractor:** Zhenhua Port Machinery Company, Ltd (ZPMC), Changxing Island **Location:** Shanghai, China**CWI Name:** Chen Chih Chein**CWI Present:** Yes No**Inspected CWI report:** Yes No N/A**Rod Oven in Use:** Yes No N/A**Electrode to specification:** Yes No N/A**Weld Procedures Followed:** Yes No N/A**Qualified Welders:** Yes No N/A**Verified Joint Fit-up:** Yes No N/A**Approved Drawings:** Yes No N/A**Approved WPS:** Yes No N/A**Delayed / Cancelled:** Yes No N/A**Bridge No:** 34-0006**Component:** OBG**Summary of Items Observed:**

Caltrans Quality Assurance (QA) Inspector, Mike Hasler was present to observe the fitup, welding and related activities associated with the fabricating of Caltrans Orthotropic Box Girder (OBG) and Tower, for the San Francisco Oa

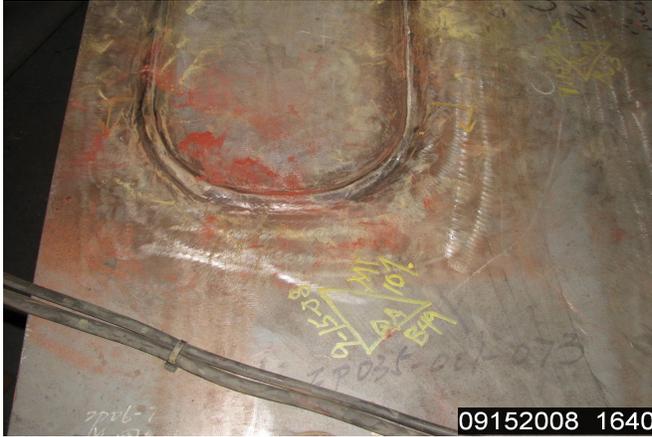
Bay 3: Caltrans QA inspector is present to witness ZPMC QC perform MT per ZPMC notification of witness inspection, document number 0001038. The subassembly is identified as edge plate EP035-001, weld 073A. ZPMC QCMT inspector is identified as Mr. Zhou Dong Yun. ZPMC QCMT inspector, at the conclusion of the inspection, informed Caltrans QA inspector that the weld is accepted by QC and no relevant indications were observed.

Caltrans QA inspector performed MT inspection of the edge plate EP035-001, weld 073A. The weld appeared to be in conformance with the project specifications. See Caltrans Magnetic Particle Test Report (TL-6028) dated September 15, 2008 for additional information. The following digital picture illustrates the inspected weld.
