Contract #: 04-0120F4Cty: SF/ALA Rte: 80 PM: 13.2/13.9File #: 69.28**WELDING INSPECTION REPORT****Resident Engineer:** Pursell, Gary**Address:** 333 Burma Road**City:** Oakland, CA 94607**Report No:** WIR-004015**Date Inspected:** 09-Sep-2008**Project Name:** SAS Superstructure**OSM Arrival Time:** 700**Prime Contractor:** American Bridge/Fluor Enterprises, a JV**OSM Departure Time:** 1500**Contractor:** Zhenhua Port Machinery Company, Ltd (ZPMC), Changxing Island **Location:** Shanghai, China

CWI Name:	Xu Le Feng / Zhu Zhong Hai	CWI Present:	Yes	No
Inspected CWI report:	Yes No N/A	Rod Oven in Use:	Yes	No N/A
Electrode to specification:	Yes No N/A	Weld Procedures Followed:	Yes	No N/A
Qualified Welders:	Yes No N/A	Verified Joint Fit-up:	Yes	No N/A
Approved Drawings:	Yes No N/A	Approved WPS:	Yes	No N/A
		Delayed / Cancelled:	Yes	No N/A
Bridge No:	34-0006	Component:	skin plate assembly

WELDING INSPECTION REPORT

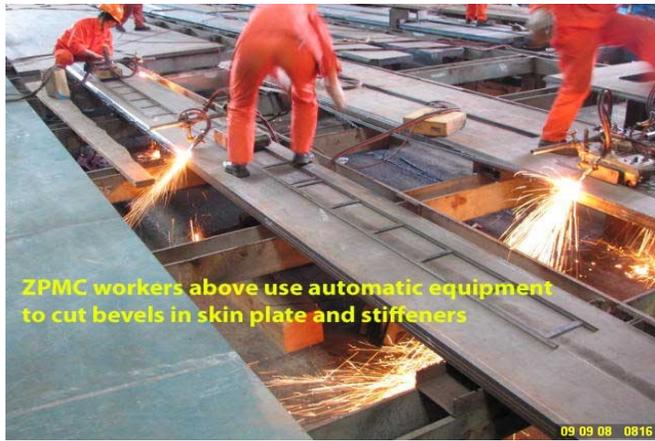
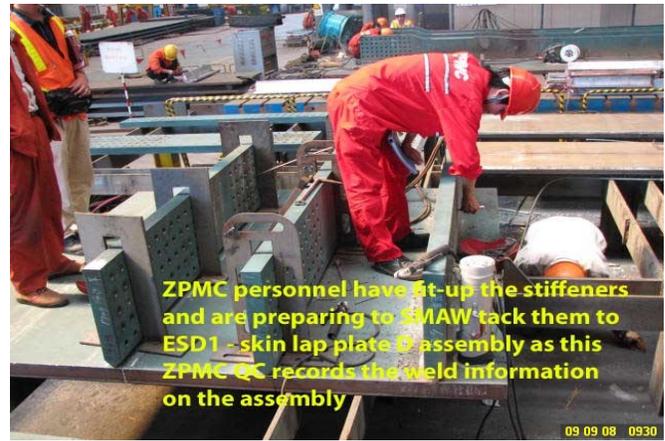
QA Inspector randomly observed approximately 65 ZPMC workers performing the following: flame heat straightening and flame cutting of beveled edge on plates; SAW of SSD1-SA17A/D-4B; FCAW-G, manual and automatic using gantry, of fill pass of stiffener to SSD1 – skin C assembly; flame heat straightening of welded stiffeners and grinding of cover pass on stiffener to SSD1 – skin A assembly; grinding of cover pass on stiffener to SSD1 – skin E assembly. Also present in this bay were ZPMC CAWI Liu Dao Feng and ZPMC CWI Xu Le Feng as well as ABF QC's Yang Yi Heng, Li Nan, C. K. Chan, and Zhang Qian Jian. Items observed appeared to comply with project specifications.

QA Inspector randomly observed approximately 50 ZPMC workers performing the following: grinding of cover pass of stiffeners on ESD1 – skin D; ZPMC UT of stiffeners to ESD1 – skin E cover passes; air-arcing of approximately 70mm x 120mm half-round holes in stiffeners at the skin plate on ESD1 – skin E assembly; grinding of tacks of stiffener to ESD1 – skin C; SMAW tacks of stiffeners to approximate 2400mm x 2400mm ESD1 – skin plate D; heat straightening of skin plate; grinding of SAW weld in skin plates. Also present in this bay were ZPMC CWI Zhu Zhong Hai and ABF QC Zhang Da Ming and C.K. Chan. Items observed appeared to comply with project specifications.
