Contract #: 04-0120F4Cty: SF/ALA Rte: 80 PM: 13.2/13.9File #: 69.28**WELDING INSPECTION REPORT****Resident Engineer:** Pursell, Gary**Address:** 333 Burma Road**City:** Oakland, CA 94607**Report No:** WIR-004079**Date Inspected:** 29-Sep-2008**Project Name:** SAS Superstructure**OSM Arrival Time:** 1400**Prime Contractor:** American Bridge/Fluor Enterprises, a JV**OSM Departure Time:** 600**Contractor:** Zhenhua Port Machinery Company, Ltd (ZPMC), Changxing Island **Location:** Shanghai China**CWI Name:** Sun Bo**CWI Present:** Yes No**Inspected CWI report:** Yes No N/A**Rod Oven in Use:** Yes No N/A**Electrode to specification:** Yes No N/A**Weld Procedures Followed:** Yes No N/A**Qualified Welders:** Yes No N/A**Verified Joint Fit-up:** Yes No N/A**Approved Drawings:** Yes No N/A**Approved WPS:** Yes No N/A**Delayed / Cancelled:** Yes No N/A**Bridge No:** 34-0006**Component:** OBG**Summary of Items Observed:**

OBG Bay 1 PMT

Ultrasonic verification of weldments

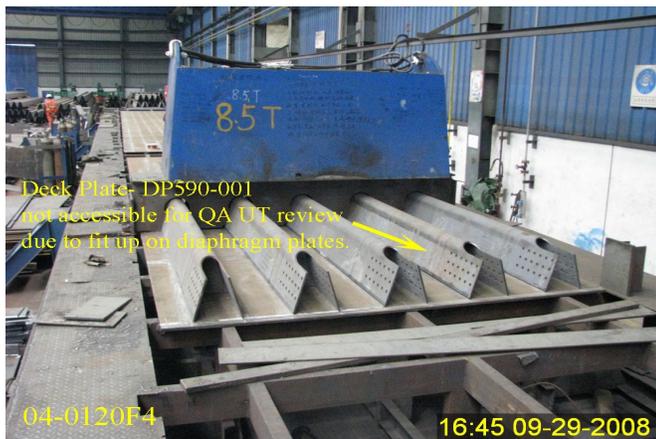
ZPMC had performed 25% UT testing for the weldments as outlined in the contract documents and had accepted the percentage as acceptable. This QA inspector performed 10% UT verification on the percentage that was performed by ZPMC and at the time of the QA review found the areas appeared to be within contract documents. After ZPMC had performed their testing and accepted the weldments. A TL-6027 will be generated for these locations. Caltrans QA Inspector performed UT verification for weld number WSD1-SA301 A/B- 7A/B after ZPMC had performed their UT examination and accepted the welds. This Caltrans QA Inspector discovered a class A indication on Face B at the toe of the weld. ZPMC Ken Zhang was informed of this finding and to inform QC UT technician that this weld needed to be re-evaluated by ZPMC.
