DEPARTMENT OF TRANSPORTATION

Contract #: 04-0120F4Cty: SF/ALA Rte: 80 PM: 13.2/13.9File #: 69.28**WELDING INSPECTION REPORT****Resident Engineer:** Pursell, Gary**Address:** 333 Burma Road**City:** Oakland, CA 94607**Report No:** WIR-004543**Date Inspected:** 03-Nov-2008**Project Name:** SAS Superstructure**OSM Arrival Time:** 2230**Prime Contractor:** American Bridge/Fluor Enterprises, a JV**OSM Departure Time:** 730**Contractor:** Zhenhua Port Machinery Company, Ltd (ZPMC), Changxing Island **Location:** Shanghai, ChinaNA

Caltrans Quality Assurance (QA) Inspector, Mike Hasler was present to observe the fitup, welding and related activities associated with the fabricating of Caltrans Orthotropic Box Girder (OBG) and Tower, for the San Francisco Oakland Bay Self Anchored Suspension Bridge, at Zhenhua Port Machinery Company (ZPMC) facility on Changxing Island.

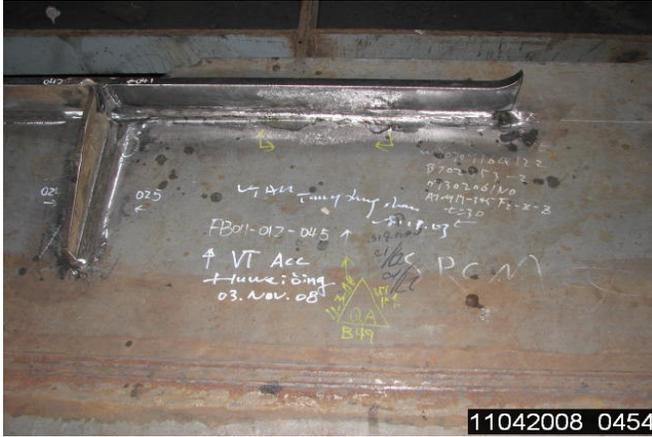
Bay 7: Caltrans QA inspector performed ultrasonic test (UT) inspection per ZPMC notification of witness inspection, document number 001340. The subassemblies are identified floor beams, welds FB015-027-043, FB010-015-043, FB011-012-045, FB011-021-045 and FB010-016-045. Caltrans QA inspector observed that the welds have been UT inspected and identified as accepted by ZPMC QC, Mr. Tang Xingshan. Caltrans QA-UT coverage was approximately 10%. The welds appeared to be in conformance with the project specifications. See Caltrans Ultrasonic Test Report (TL-6027) dated, November 03, 2008 for additional information. The following digital picture illustrates inspected weld FB011-012-045.
