DEPARTMENT OF TRANSPORTATION

Quality Assurance and Source Inspection

Contract #: 04-0120F4Cty: SF/ALA Rte: 80 PM: 13.2/13.9File #: 69.28**WELDING INSPECTION REPORT****Resident Engineer:** Pursell, Gary**Address:** 333 Burma Road**City:** Oakland, CA 94607**Report No:** WIR-004597**Date Inspected:** 13-Nov-2008**Project Name:** SAS Superstructure**OSM Arrival Time:** 2230**Prime Contractor:** American Bridge/Fluor Enterprises, a JV**OSM Departure Time:** 730**Contractor:** Zhenhua Port Machinery Company, Ltd (ZPMC), Changxing Island **Location:** Shanghai, China**CWI Name:****CWI Present:**

Bridge No: 34-0006**Component:** OBG & Tower**Summary of Items Observed:**

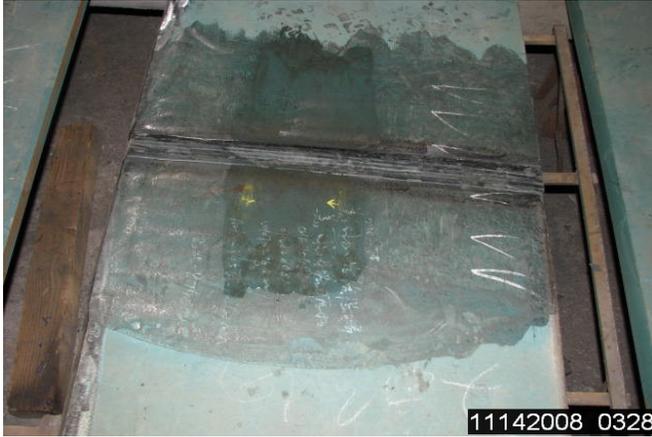
Heavy Shop 2: Caltrans QA inspector performed ultrasonic test (UT) inspection per ZPMC notification of witness inspection, document number 001412. The subassembly is identified as Lift 1, shin plate D, welds

WSD1-SA80A/E-42B and WSD1-SA80A/E-45B. Caltrans QA inspector observed that the welds have been UT inspected and accepted by ZPMC QC. Caltrans QA-UT coverage was approximately 10%. The welds appeared to be in conformance with the project specifications. See Caltrans Ultrasonic Test Report (TL-6027) dated, November 13, 2008 for additional information. The following digital picture illustrates inspected weld WSD1-SA80A/E-54B.

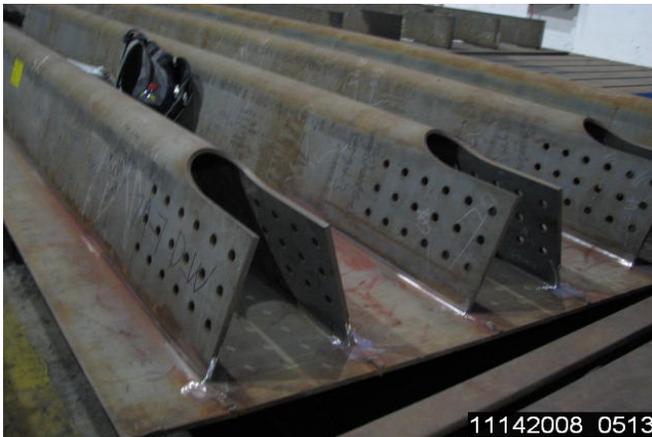
Heavy Shop 3: Caltrans QA inspector performed magnetic particle test (MT) inspection per ZPMC notification of witness inspection, document number 001411. The subassemblies are identified as OBG deck panels; weld DP090-001-001, 002, 003, 004, 005 and 006 partial joint penetration cover pass welds joining u-rib to the deck panel plate. Also, deck panel welds DP117-001-001, 002, 003, 004, 005, 006, 007 and 008. Caltrans QA inspector observed that the welds have been MT inspected and identified as accepted by ZPMC QC. Caltrans QA-MT coverage was approximately 10%. The welds appeared to be in conformance with the project specifications. See Caltrans Magnetic Particle Test Report (TL-6028) dated, November 13, 2008 for additional information. The following digital picture illustrates inspected deck panel DP117-001.
