DEPARTMENT OF TRANSPORTATION

Quality Assurance and Source Inspection

Contract #: 04-0120F4Cty: SF/ALA Rte: 80 PM: 13.2/13.9File #: 69.28**WELDING INSPECTION REPORT****Resident Engineer:** Pursell, Gary**Address:** 333 Burma Road**City:** Oakland, CA 94607**Report No:** WIR-004821**Date Inspected:** 26-Nov-2008**Project Name:** SAS Superstructure**OSM Arrival Time:** 630**Prime Contractor:** American Bridge/Fluor Enterprises, a JV**OSM Departure Time:** 1530**Contractor:** Zhenhua Port Machinery Company, Ltd (ZPMC), Changxing Island **Location:** Shanghai, China**CWI Name:** Sun Wei**CWI Present:** Yes No**Inspected CWI report:** Yes No N/A**Rod Oven in Use:** Yes No N/A**Electrode to specification:** Yes No N/A**Weld Procedures Followed:** Yes No N/A**Qualified Welders:** Yes No N/A**Verified Joint Fit-up:** Yes No N/A**Approved Drawings:** Yes No N/A**Approved WPS:** Yes No N/A**Delayed / Cancelled:** Yes No N/A**Bridge No:** 34-0006**Component:** OBG**Summary of Items Observed:**

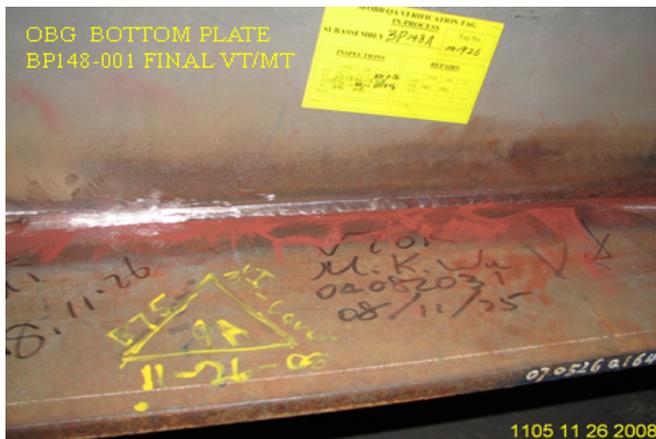
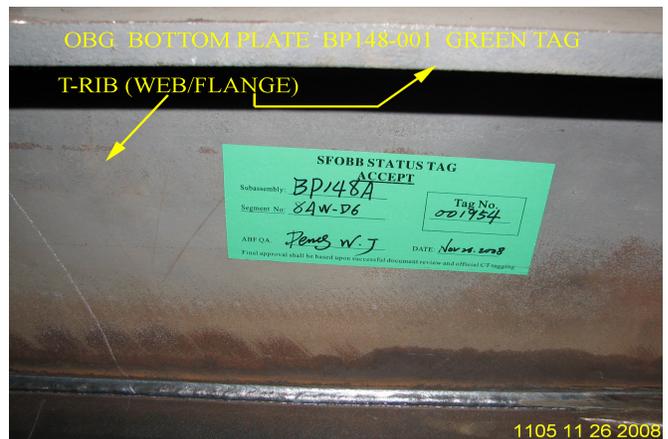
The QA Inspector randomly observed ZPMC NDT Technician Bo Tin Rui, utilizing the Magnetic Particle Testing (MT) Method to perform a final MT examination on the cover pass of the fillet welds on Bottom Plate BP94A Yellow Tag 001929 (BP094-001) WJ's 007 through 018 and 043 through 054, BP148A Yellow Tag 001926 (BP148-001) WJ's 007 through 018 and 043 through 054 and Edge Plate EP65A Yellow Tag 001928 (EP065-001) Location 7AW-F9 WJ's 001 through 004. There appeared to be no indications and ZPMC QC accepted all the above listed welds.

The QA Inspector performed a 100% final Visual Testing (VT) and 10% MT verification on the cover pass of the fillet welds on Bottom Plates BP94A Yellow Tag 001929/Green Tag 001953 (BP094-001) Location 8CE-D6 WJ's 007 through 018 & 043 through 054, BP148A Yellow Tag 001926/Green Tag 001954 (BP148-001) Location 8CW-D6 WJ's 007 through 018 & 043 through 054 and Edge Plate EP65A Yellow Tag 001928/Green Tag 001953 (EP065-001) Location 7AW-F9 WJ's 001 through 004. There appeared to be no indications and the QA Inspector accepted all the above listed welds.
