DEPARTMENT OF TRANSPORTATION

Quality Assurance and Source Inspection

Contract #: 04-0120F4Cty: SF/ALA Rte: 80 PM: 13.2/13.9File #: 69.28**WELDING INSPECTION REPORT****Resident Engineer:** Pursell, Gary**Address:** 333 Burma Road**City:** Oakland, CA 94607**Report No:** WIR-004824**Date Inspected:** 30-Nov-2008**Project Name:** SAS Superstructure**OSM Arrival Time:** 630**Prime Contractor:** American Bridge/Fluor Enterprises, a JV**OSM Departure Time:** 1530**Contractor:** Zhenhua Port Machinery Company, Ltd (ZPMC), Changxing Island **Location:** Shanghai, China**CWI Name:** Sun Wei**CWI Present:** Yes No**Inspected CWI report:** Yes No N/A**Rod Oven in Use:** Yes No N/A**Electrode to specification:** Yes No N/A**Weld Procedures Followed:** Yes No N/A**Qualified Welders:** Yes No N/A**Verified Joint Fit-up:** Yes No N/A**Approved Drawings:** Yes No N/A**Approved WPS:** Yes No N/A**Delayed / Cancelled:** Yes No N/A**Bridge No:** 34-0006**Component:** OBG**Summary of Items Observed:**

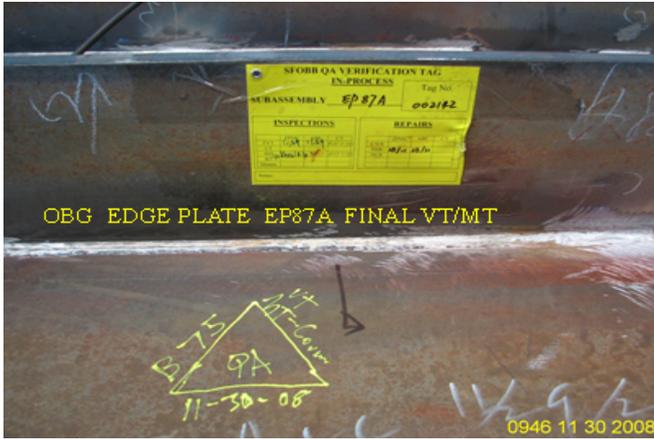
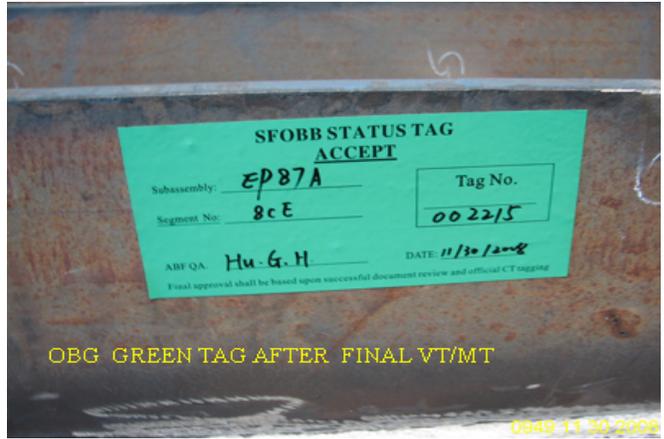
The QA Inspector performed a 100% final Visual Testing (VT) and 10% MT verification on the cover pass of the fillet welds on Edge Plates EP70A Yellow Tag 002141/Green Tag 002216 (EP070-001) Location 7DW WJ's 005 through 008, EP87A Yellow Tag 002142/Green Tag 002215 (EP087-001) Location 8CE WJ's 001 through 04, EP78B Yellow Tag 002145/Green Tag 002212 (EP078-001) Location 7BE WJ's 017 through 020, Edge Plate EP73A Yellow Tag 002146/Green Tag 002211 (EP073-001) Location 8AW WJ's 005 through 008, Edge Plate EP75A Yellow Tag 002147/Green Tag 002210 (EP075-001) Location 8CW WJ's 001 through 004, Edge Plate EP63A Yellow Tag 002140/Green Tag 002217 (EP063-001) Location 8BW WJ's 001 through 004, Edge Plate EP80A Yellow Tag 002144/Green Tag 002213 (EP073-001) Location 7CE WJ's 001 through 004 and Edge Plate EP68A Yellow Tag 002143/Green Tag 002214 (EP068-001) Location 7CW WJ's 001 through 004. There appeared to be no indications and the QA Inspector accepted all the above listed welds. The attached photographs provide additional detail.
