Contract #: 04-0120F4Cty: SF/ALA Rte: 80 PM: 13.2/13.9File #: 69.28**WELDING INSPECTION REPORT****Resident Engineer:** Pursell, Gary**Address:** 333 Burma Road**City:** Oakland, CA 94607**Report No:** WIR-005455**Date Inspected:** 07-Feb-2009**Project Name:** SAS Superstructure**OSM Arrival Time:** 645**Prime Contractor:** American Bridge/Fluor Enterprises, a JV**OSM Departure Time:** 1845**Contractor:** Zhenhua Port Machinery Company, Ltd (ZPMC), Changxing Island **Location:** Shanghai, China**CWI Name:** See Below**CWI Present:** Yes No**Inspected CWI report:** Yes No N/A**Rod Oven in Use:** Yes No N/A**Electrode to specification:** Yes No N/A**Weld Procedures Followed:** Yes No N/A**Qualified Welders:** Yes No N/A**Verified Joint Fit-up:** Yes No N/A**Approved Drawings:** Yes No N/A**Approved WPS:** Yes No N/A**Delayed / Cancelled:** Yes No N/A**Bridge No:** 34-0006**Component:** OBG Fabrication**Summary of Items Observed:**

OBG Bay 9

# WELDING INSPECTION REPORT

## OBG Bay 6

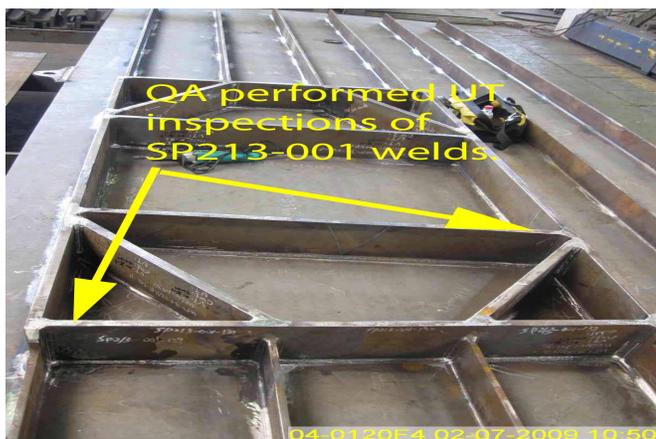
This QA Inspector performed random ultrasonic (UT) inspections of OBG floor beam welds SP213-001-018, SP213-001-123, SP213-001-129, SP207-004-037, SP207-004-031 and SP207-004-064. These welds are listed on ZPMC Notification of Witness Inspection document 001937. The QA Inspector observed the welds that were ultrasonically inspected by this QA Inspector appear to comply with AWS D1.5 UT requirements. For additional information on this inspection see the TL6027 Ultrasonic Test Report and the photograph below.
