**DEPARTMENT OF TRANSPORTATION**

Contract #: 04-0120F4Cty: SF/ALA Rte: 80 PM: 13.2/13.9File #: 69.28**WELDING INSPECTION REPORT****Resident Engineer:** Pursell, Gary**Address:** 333 Burma Road**City:** Oakland, CA 94607**Report No:** WIR-006966**Date Inspected:** 01-May-2009**Project Name:** SAS Superstructure**OSM Arrival Time:** 1900**Prime Contractor:** American Bridge/Fluor Enterprises, a JV**OSM Departure Time:** 700**Contractor:** Zhenhua Port Machinery Company, Ltd (ZPMC), Changxing Island **Location:** Shanghai, China**CWI Name:** See Below**CWI Present:** Yes No**Inspected CWI report:** Yes No N/A**Rod Oven in Use:** Yes No N/A**Electrode to specification:** Yes No N/A**Weld Procedures Followed:** Yes No N/A**Qualified Welders:** Yes No N/A**Verified Joint Fit-up:** Yes No N/A**Approved Drawings:** Yes No N/A**Approved WPS:** Yes No N/A**Delayed / Cancelled:** Yes No N/A**Bridge No:** 34-0006**Component:** OBG and Tower Fabrication**Summary of Items Observed:**

## WELDING INSPECTION REPORT

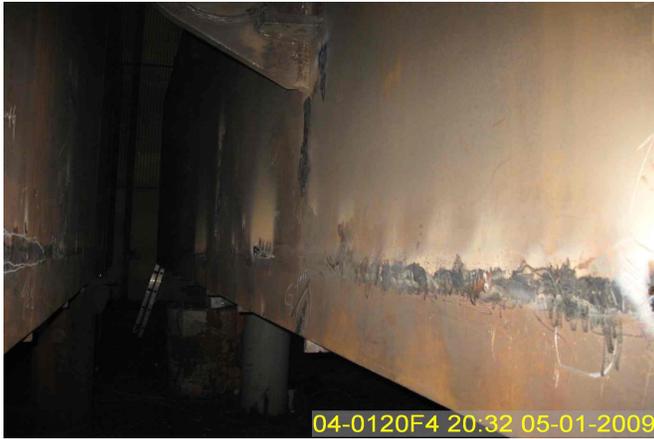
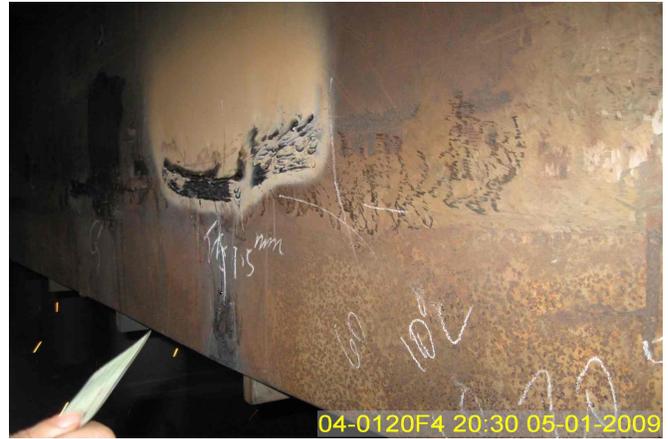
The QA Inspector observed ZPMC welder Mr. Xu Zichuang, stencil 205098 is using the shielded metal arc welding process to make base material repairs on the side of segment 1AAW. The QA Inspector observed a welding current of approximately 160 amps and the base material approximately 50 mm from where the welding is being made appears to be at an ambient temperature. The QA Inspector asked ABF representative Mr. Shen Ru Shan what is the minimum required base material temperature and he said the base material needs to be at a

minimum of 60 degrees Celsius. The QA Inspector asked Mr. Shen Ru Shan who is the QC representative for this shop and he summoned ZPMC Quality Control (QC) Inspector Mr. Song Wui who said he had been at the other end of Bay 2 and he had not been able to monitor the preheating where this welding had been performed. The QA Inspector asked Mr. Song Wui who is the responsible Certified Welding Inspector (CWI) for this location and after he made multiple phone calls he indicated a CWI will be in Bay 2 in about 5 minutes to discuss this welding preheat problem. A short time later ZPMC CWI Mr. Zhicheng Wu arrived in Bay 2 and after discussion with Mr. Song Wui, Mr. Zhicheng Wu told this QA Inspector that the base material might have previously been preheated and that the metal has now cooled and that he will talk to the welder and he will instruct the welder to preheat the base material prior to making any additional welds. Mr. Zhicheng Wu said he will have the weld ground and he will perform a close inspection of the location where this base metal weld repair had been made. The QA Inspector later observed ZPMC welder Mr. Xu Zichuang using a torch to preheat the base material where he is preparing to weld. Items observed by the QA Inspector do not appear to fully comply with project specifications.
