**DEPARTMENT OF TRANSPORTATION**

Contract #: 04-0120F4Cty: SF/ALA Rte: 80 PM: 13.2/13.9File #: 69.28**WELDING INSPECTION REPORT****Resident Engineer:** Pursell, Gary**Address:** 333 Burma Road**City:** Oakland, CA 94607**Report No:** WIR-008024**Date Inspected:** 01-Aug-2009**Project Name:** SAS Superstructure**OSM Arrival Time:** 1900**Prime Contractor:** American Bridge/Fluor Enterprises, a JV**OSM Departure Time:** 700**Contractor:** Zhenhua Port Machinery Company, Ltd (ZPMC), Changxing Island **Location:** Shanghai, China

**Bridge No:** 34-0006**Component:** Assembly bays 13 and 14**Summary of Items Observed:**

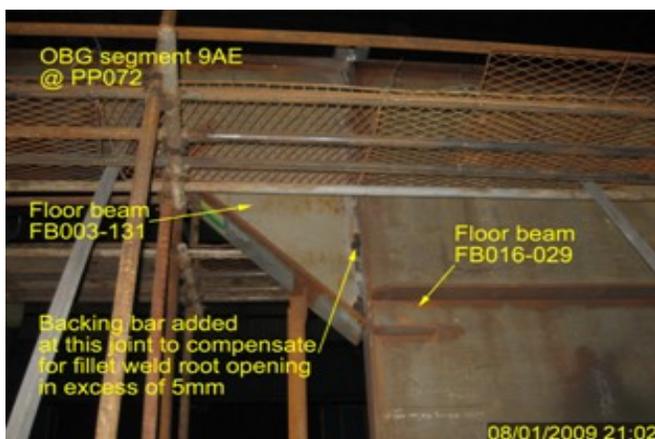
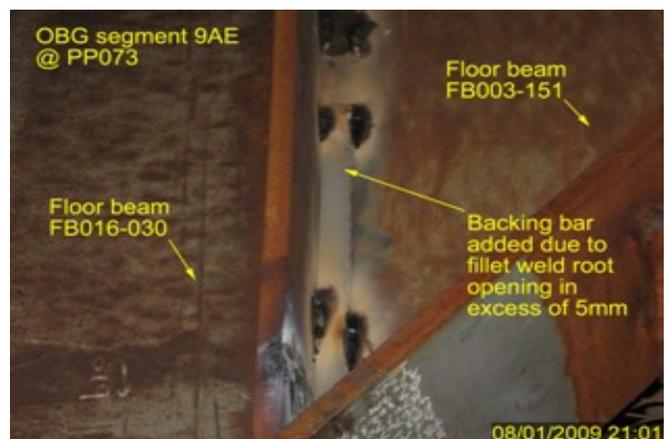
This QA observed that the contractor appears to have deviated from the weld joint design specified on the approved drawings. The contractor appears to have changed the weld joint from a fillet weld to a Complete Joint Penetration (CJP) weld with steel backing without the Engineers approval. According to the contractors QC inspector, Mr Zhang Xian Ji, the weld design was changed in order to compensate for a joint root opening in excess of 5mm. This condition exists in the following locations: OBG segment 9AE @ PP072 weld joining floor beam FB003-131 to floor beam FB016-029; OBG segment 9AE @ PP073 weld joining floor beam FB003-151 to floor beam FB016-030 and OBG segment 9BE @ PP074 weld joining floor beam FB003-142 to floor beam FB020-007. See attached photos for details. This QA has submitted an incident report concerning this issue.
