DEPARTMENT OF TRANSPORTATION

Quality Assurance and Source Inspection

Contract #: 04-0120F4Cty: SF/ALA Rte: 80 PM: 13.2/13.9File #: 69.28**WELDING INSPECTION REPORT****Resident Engineer:** Pursell, Gary**Address:** 333 Burma Road**City:** Oakland, CA 94607**Report No:** WIR-008728**Date Inspected:** 30-Aug-2009**Project Name:** SAS Superstructure**OSM Arrival Time:** 700**Prime Contractor:** American Bridge/Fluor Enterprises, a JV**OSM Departure Time:** 1900**Contractor:** Zhenhua Port Machinery Company, Ltd (ZPMC), Changxing Island **Location:** Shanghai, China**CWI Name:** Li Zhi Jiang**CWI Present:** Yes No**Inspected CWI report:** Yes No N/A**Rod Oven in Use:** Yes No N/A**Electrode to specification:** Yes No N/A**Weld Procedures Followed:** Yes No N/A**Qualified Welders:** Yes No N/A**Verified Joint Fit-up:** Yes No N/A**Approved Drawings:** Yes No N/A**Approved WPS:** Yes No N/A**Delayed / Cancelled:** Yes No N/A**Bridge No:** 34-0006**Component:** OBG crossbeams**Summary of Items Observed:**

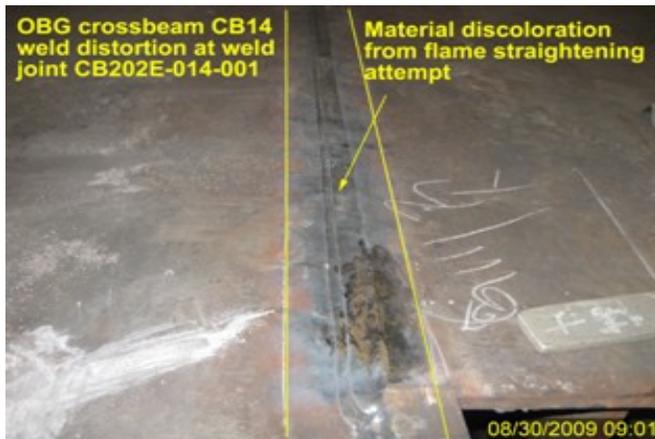
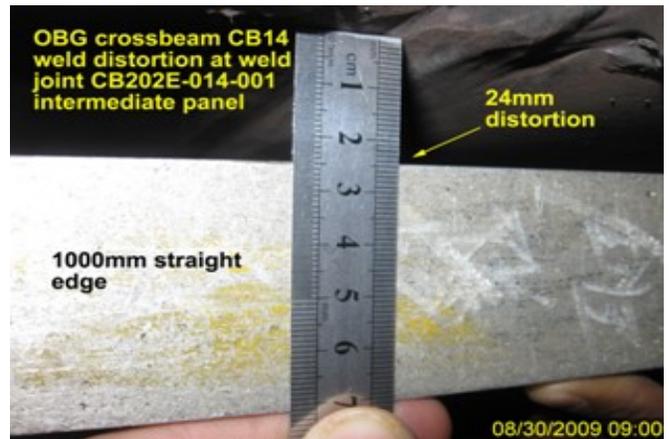
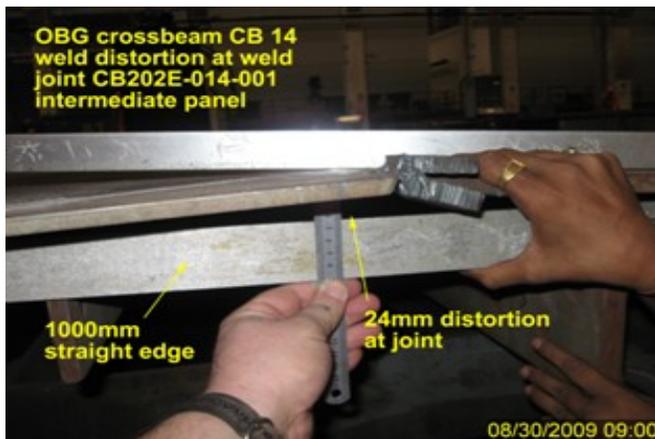
OBG cross beam CB14 bay 3

This QA observed the contractor performing flame straightening on 15mm material without the Engineers approval. The procedure presented to this QA on the shop floor (HSR1(B)-7358) indicated that the distortion was

5mm. This QA measured the distortion at 24mm in 1000mm. The weld joint is identified as CB202E-014-001. The contract Special Provisions section 8-3.01 states “for material equal to or less than 16mm, the contractor shall not heat straighten members more than 6 in 1000 without prior approval of the Engineer”. This QA informed ZPMC QC CWI identified as Mr. Li Zhi Jiang that an incident report would be generated for this issue. See attached photos for details.
