**DEPARTMENT OF TRANSPORTATION**

Contract #: 04-0120F4Cty: SF/ALA Rte: 80 PM: 13.2/13.9File #: 69.28**WELDING INSPECTION REPORT****Resident Engineer:** Pursell, Gary**Address:** 333 Burma Road**City:** Oakland, CA 94607**Report No:** WIR-008780**Date Inspected:** 07-Sep-2009**Project Name:** SAS Superstructure**OSM Arrival Time:** 700**Prime Contractor:** American Bridge/Fluor Enterprises, a JV**OSM Departure Time:** 1900**Contractor:** Zhenhua Port Machinery Company, Ltd (ZPMC), Changxing Island **Location:** Shanghai, China**CWI Name:** Guo Yan Fei**CWI Present:** Yes No**Inspected CWI report:** Yes No N/A**Rod Oven in Use:** Yes No N/A**Electrode to specification:** Yes No N/A**Weld Procedures Followed:** Yes No N/A**Qualified Welders:** Yes No N/A**Verified Joint Fit-up:** Yes No N/A**Approved Drawings:** Yes No N/A**Approved WPS:** Yes No N/A**Delayed / Cancelled:** Yes No N/A**Bridge No:** 34-0006**Component:** Crossbeams**Summary of Items Observed:**

**OBG CROSS BEAM CB1**

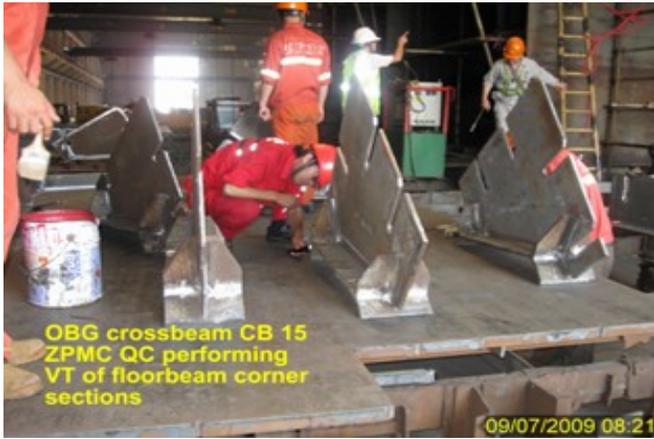
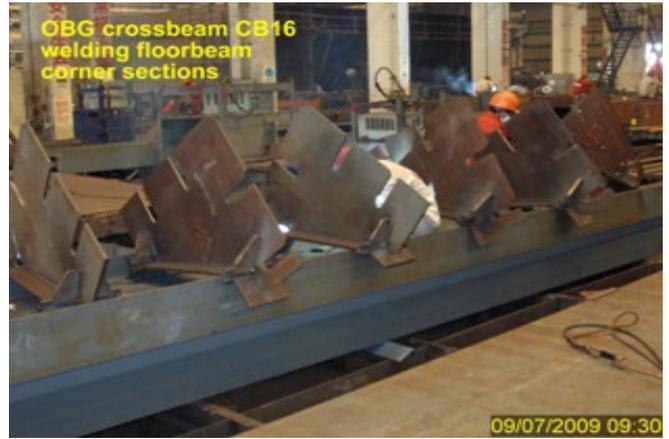
Unless otherwise noted, all work observed on this date appeared to be in general compliance with the applicable contract documents.
