**DEPARTMENT OF TRANSPORTATION**

Contract #: 04-0120F4Cty: SF/ALA Rte: 80 PM: 13.2/13.9File #: 69.28**WELDING INSPECTION REPORT****Resident Engineer:** Pursell, Gary**Address:** 333 Burma Road**City:** Oakland, CA 94607**Report No:** WIR-008967**Date Inspected:** 03-Sep-2009**Project Name:** SAS Superstructure**OSM Arrival Time:** 1845**Prime Contractor:** American Bridge/Fluor Enterprises, a JV**OSM Departure Time:** 645**Contractor:** Zhenhua Port Machinery Company, Ltd (ZPMC), Changxing Island **Location:** Shanghai, China**CWI Name:** Wan Wen Zhong**CWI Present:** Yes No**Inspected CWI report:** Yes No N/A**Rod Oven in Use:** Yes No N/A**Electrode to specification:** Yes No N/A**Weld Procedures Followed:** Yes No N/A**Qualified Welders:** Yes No N/A**Verified Joint Fit-up:** Yes No N/A**Approved Drawings:** Yes No N/A**Approved WPS:** Yes No N/A**Delayed / Cancelled:** Yes No N/A**Bridge No:** 34-0006**Component:** OBG and Tower**Summary of Items Observed:**

**OBG Trial Assembly:**

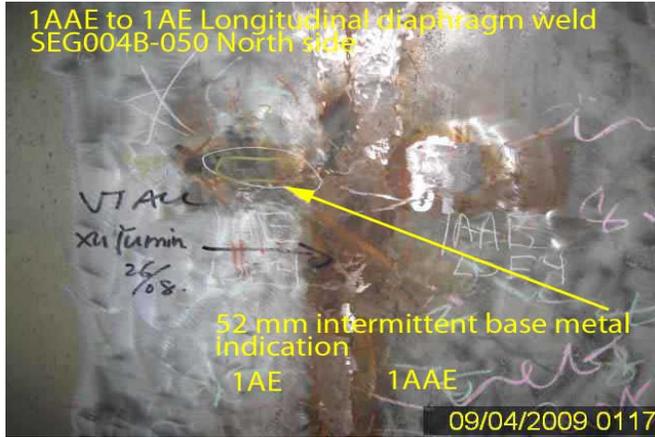
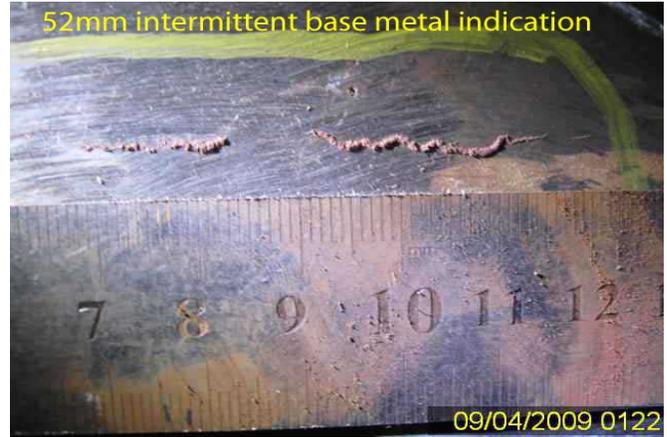
This QA inspector performed Magnetic Particle Testing (MT) verification of OBG Segment 1AAE to 1AE longitudinal diaphragm splice weld SEG004B-050 at panel point 8.5. This QA Inspector located 4 linear indications in the base metal that appear to be in the area where temporary weld fixtures were removed. Indications were found on north side of the weld at Y locations 1160 mm, 2705mm, 4140 mm and 3065 mm. The length of indications ranged from 12 mm to 52 mm. This QA inspector generated an MT report for this date. See the attached photos below of the above mentioned indications.
