Contract #: 04-0120F4Cty: SF/ALA Rte: 80 PM: 13.2/13.9File #: 69.28**WELDING INSPECTION REPORT****Resident Engineer:** Pursell, Gary**Address:** 333 Burma Road**City:** Oakland, CA 94607**Report No:** WIR-009130**Date Inspected:** 08-Sep-2009**Project Name:** SAS Superstructure**OSM Arrival Time:** 1900**Prime Contractor:** American Bridge/Fluor Enterprises, a JV**OSM Departure Time:** 700**Contractor:** Zhenhua Port Machinery Company, Ltd (ZPMC), Changxing Island **Location:** Shanghai, China

OBG SEGMENT 2AW-2BW

WELDING INSPECTION REPORT

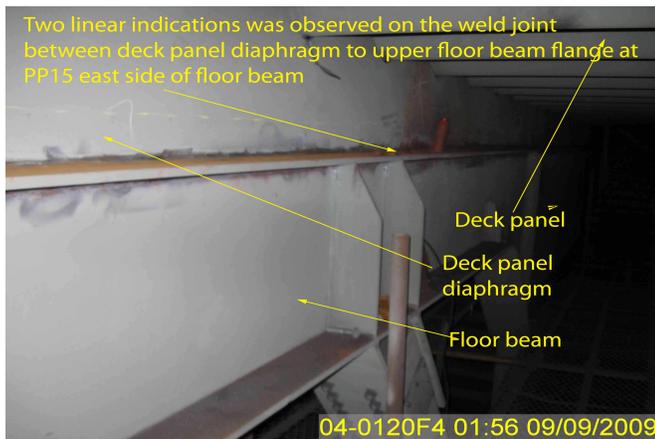
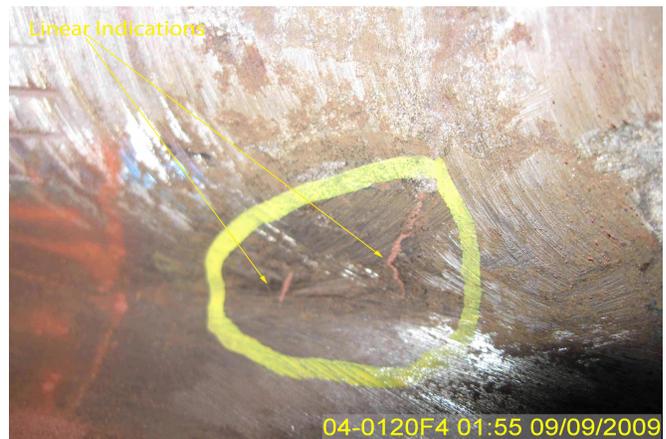
During the random verification Magnetic Particle Testing (MT) on the weld between deck panel diaphragms to upper floor beam flange at PP15 east side of floor beam in OBG segment 2AW. This QA Inspector discovered two transverse linear indications. The MT indications are approximately 5 to 10 mm in length and are located 1010 cm from the end of the weld (counter weight side). MT inspections of this weld have been previously performed and accepted by ZPMC MT personnel. For additional information see attached photos.
