DEPARTMENT OF TRANSPORTATION

Quality Assurance and Source Inspection

Contract #: 04-0120F4Cty: SF/ALA Rte: 80 PM: 13.2/13.9File #: 69.28**WELDING INSPECTION REPORT****Resident Engineer:** Pursell, Gary**Address:** 333 Burma Road**City:** Oakland, CA 94607**Report No:** WIR-009143**Date Inspected:** 12-Sep-2009**Project Name:** SAS Superstructure**OSM Arrival Time:** 645**Prime Contractor:** American Bridge/Fluor Enterprises, a JV**OSM Departure Time:** 1845**Contractor:** Zhenhua Port Machinery Company, Ltd (ZPMC), Changxing Island **Location:** Shanghai, China**CWI Name:** Chen Xi**CWI Present:** Yes No**Inspected CWI report:** Yes No N/A**Rod Oven in Use:** Yes No N/A**Electrode to specification:** Yes No N/A**Weld Procedures Followed:** Yes No N/A**Qualified Welders:** Yes No N/A**Verified Joint Fit-up:** Yes No N/A**Approved Drawings:** Yes No N/A**Approved WPS:** Yes No N/A**Delayed / Cancelled:** Yes No N/A**Bridge No:** 34-0006**Component:** OBG Components**Summary of Items Observed:**

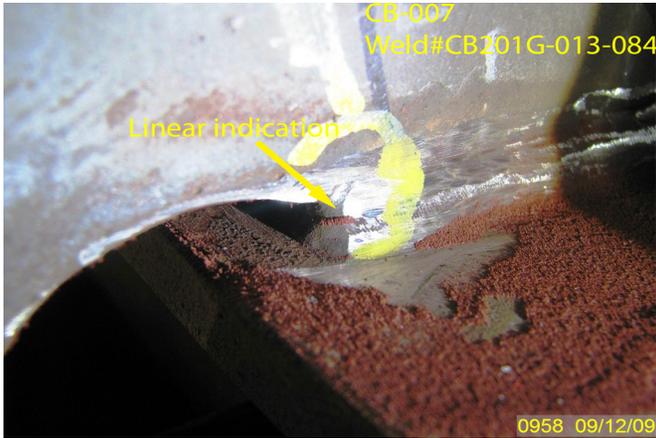
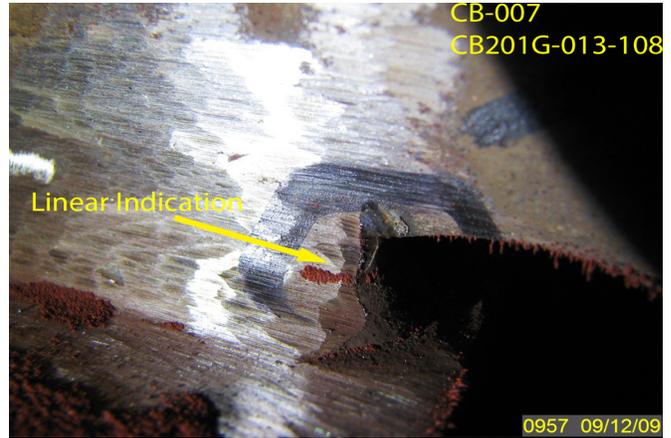
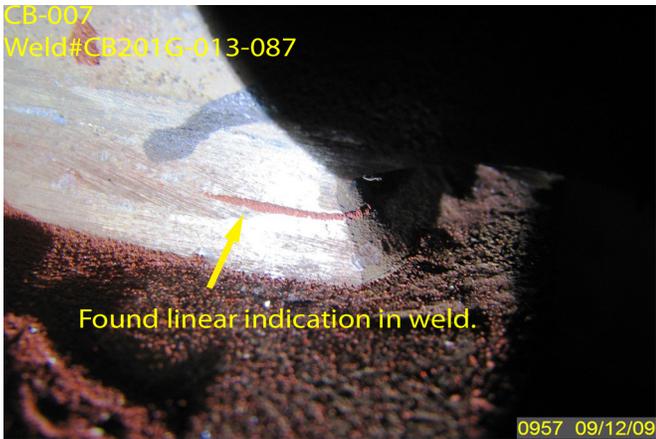
This QA inspector witnessed Magnetic particle testing on CB-007 welds performed by ZPMC QC. ZPMC QC found total nine (9) linear indications in 10% magnetic particle testing. The defective welds are listed below. ZPMC QC increase inspection percentage up to 100%. For further information, please see attached pictures.

CB201G-013-088, 084, 087, 085, 108 and CB201G-014-049, 051, 052, 050
