DEPARTMENT OF TRANSPORTATION

Quality Assurance and Source Inspection

Contract #: 04-0120F4Cty: SF/ALA Rte: 80 PM: 13.2/13.9File #: 69.28**WELDING INSPECTION REPORT****Resident Engineer:** Pursell, Gary**Address:** 333 Burma Road**City:** Oakland, CA 94607**Report No:** WIR-009213**Date Inspected:** 24-Sep-2009**Project Name:** SAS Superstructure**OSM Arrival Time:** 1900**Prime Contractor:** American Bridge/Fluor Enterprises, a JV**OSM Departure Time:** 700**Contractor:** Zhenhua Port Machinery Company, Ltd (ZPMC), Changxing Island **Location:** Shanghai, China**CWI Name:** See Below**CWI Present:** Yes No**Inspected CWI report:** Yes No N/A**Rod Oven in Use:** Yes No N/A**Electrode to specification:** Yes No N/A**Weld Procedures Followed:** Yes No N/A**Qualified Welders:** Yes No N/A**Verified Joint Fit-up:** Yes No N/A**Approved Drawings:** Yes No N/A**Approved WPS:** Yes No N/A**Delayed / Cancelled:** Yes No N/A**Bridge No:** 34-0006**Component:** OBG & Tower Fabrication**Summary of Items Observed:**

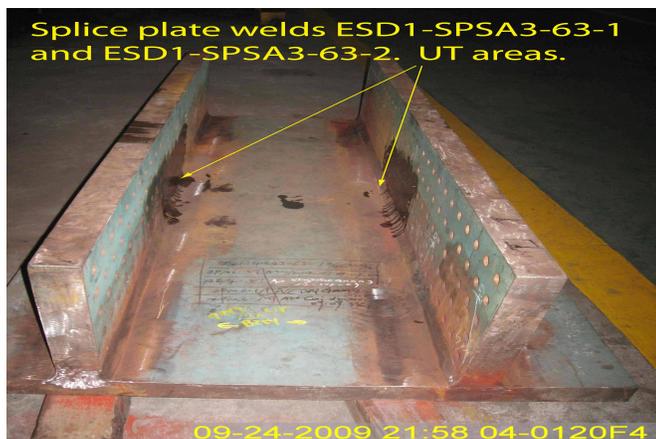
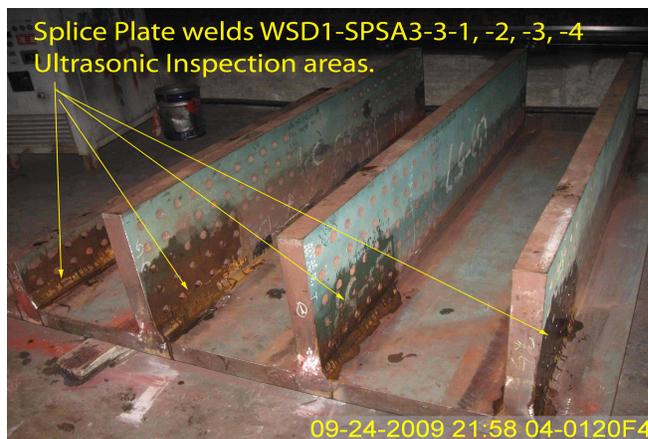
ZPMC issued "Inspection Notification Sheet" number 4281 informing QA that ZPMC has completed visual (VT), magnetic particle (MT) and ultrasonic inspections (UT) of west tower skin D interior splice plate welds WSD1-SPSA3-3-1, WSD1-SPSA3-3-2, WSD1-SPSA3-3-3, WSD1-SPSA3-3-4 and east tower skin B interior splice plate welds ESD1-SPSA3-63-1 and ESD1-SPSA3-63-2. This QA Inspector observed ZPMC QC personnel had previously marked these seven welds as being VT, MT and UT accepted. This QA Inspector performed

random visual inspections of these welds and observed several weld surfaces that have arc strikes and areas where adjacent weld passes were not smoothly transitioned together, leaving a shallow linear shaped trough in the surface of the welds. This QA Inspector showed ZPMC CWI Mr. An Qing Xiang several of these areas and Mr. An Qing Xiang marked these and several additional areas. A ZPMC worker used an electric grinder to blend or remove the visual rejections. It appears that ZPMC ground various locations on all six of the welds listed above. This QA Inspector informed Mr. An Qing Xiang that ZPMC needs to perform magnetic particle inspections of the areas that have been ground. Mr. An Qing Xiang said that ZPMC does not have any magnetic particle inspectors available to perform MT inspections this shift and that ZPMC will perform MT inspections tomorrow during the day shift. This QA Inspector also informed ZPMC QC representative Mr. Zhang Jidai that these ground areas require magnetic particle inspections. This QA Inspector performed random ultrasonic inspections of approximately 10 percent length of each of the six welds listed above and items observed by this QA Inspector appear to comply with AWS D1.5 UT requirements. For additional information on this inspections see the TL6027 Ultrasonic Test Report.
