DEPARTMENT OF TRANSPORTATION

Quality Assurance and Source Inspection

Contract #: 04-0120F4Cty: SF/ALA Rte: 80 PM: 13.2/13.9File #: 69.28**WELDING INSPECTION REPORT****Resident Engineer:** Pursell, Gary**Address:** 333 Burma Road**City:** Oakland, CA 94607**Report No:** WIR-010335**Date Inspected:** 28-Oct-2009**Project Name:** SAS Superstructure**OSM Arrival Time:** 645**Prime Contractor:** American Bridge/Fluor Enterprises, a JV**OSM Departure Time:** 1845**Contractor:** Zhenhua Port Machinery Company, Ltd (ZPMC), Changxing Island **Location:** Shanghai, China**CWI Name:** Chen Xi**CWI Present:** Yes No**Inspected CWI report:** Yes No N/A**Rod Oven in Use:** Yes No N/A**Electrode to specification:** Yes No N/A**Weld Procedures Followed:** Yes No N/A**Qualified Welders:** Yes No N/A**Verified Joint Fit-up:** Yes No N/A**Approved Drawings:** Yes No N/A**Approved WPS:** Yes No N/A**Delayed / Cancelled:** Yes No N/A**Bridge No:** 34-0006**Component:** OBG COMPONENT**Summary of Items Observed:**

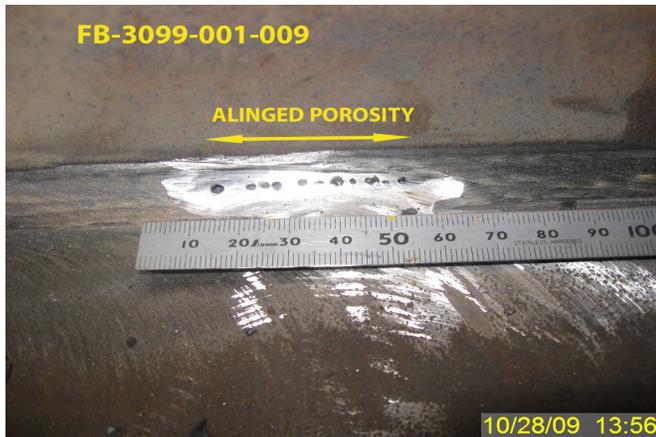
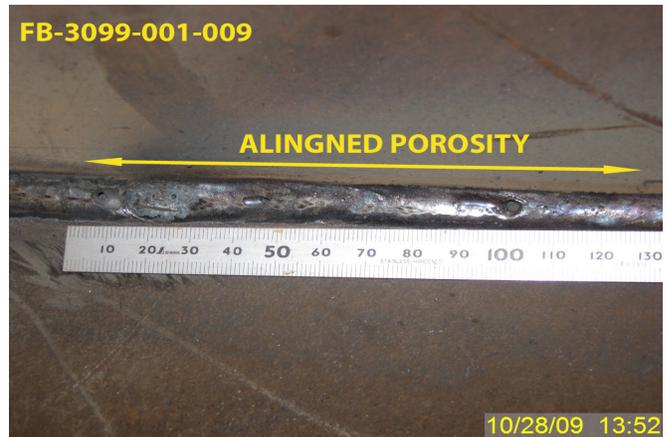
During random in-process visual inspection the QA inspector observed lots of porosity and wormhole at the weld area on Floor Beam .

The Weld number is noted as FB-3099-001-001,009 and 010.

For details see attached picture.
