Contract #: 04-0120F4Cty: SF/ALA Rte: 80 PM: 13.2/13.9File #: 69.28**WELDING INSPECTION REPORT****Resident Engineer:** Pursell, Gary**Address:** 333 Burma Road**City:** Oakland, CA 94607**Report No:** WIR-011823**Date Inspected:** 05-Feb-2010**Project Name:** SAS Superstructure**OSM Arrival Time:** 700**Prime Contractor:** American Bridge/Fluor Enterprises, a JV**OSM Departure Time:** 1900**Contractor:** Zhenhua Port Machinery Company, Ltd (ZPMC), Changxing Island **Location:** Shanghai, China**CWI Name:** Wuzhi Chang, Li Yang**CWI Present:** Yes No**Inspected CWI report:** Yes No N/A**Rod Oven in Use:** Yes No N/A**Electrode to specification:** Yes No N/A**Weld Procedures Followed:** Yes No N/A**Qualified Welders:** Yes No N/A**Verified Joint Fit-up:** Yes No N/A**Approved Drawings:** Yes No N/A**Approved WPS:** Yes No N/A**Delayed / Cancelled:** Yes No N/A**Bridge No:** 34-0006**Component:** Orthotropic Box Girder (OBG)**Summary of Items Observed:**

WELDING INSPECTION REPORT

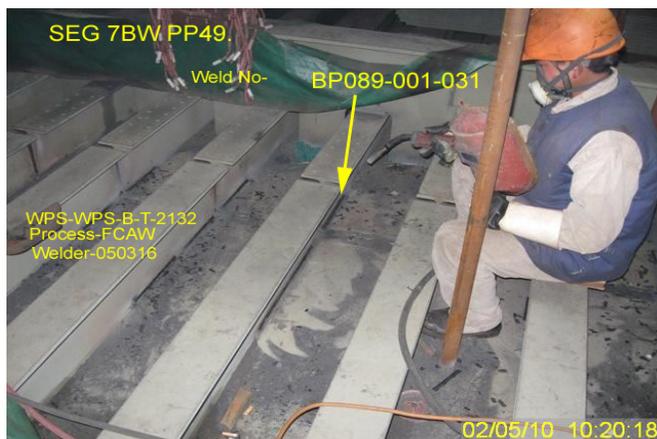
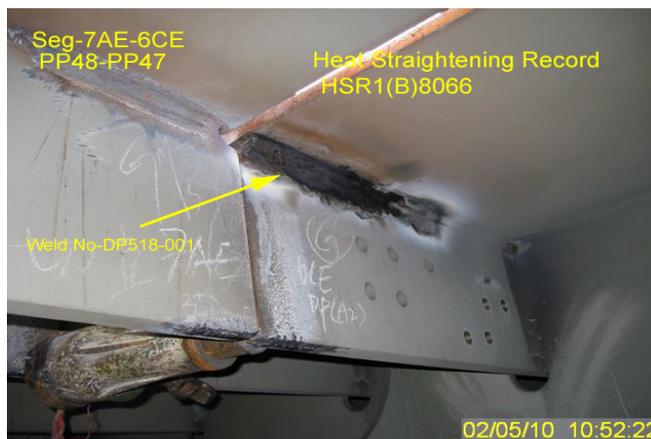
Segment#7AE-6CE

This QA inspector observed, Heat Straightening of weld joint identified as DP518-001
ZPM QC is identified as Wang Lai Yang. The variables recorded by QC appeared to comply with the Heat Straightening Report (HSR) was HSR1 (B) -8066.
