DEPARTMENT OF TRANSPORTATION

Quality Assurance and Source Inspection

Contract #: 04-0120F4Cty: SF/ALA Rte: 80 PM: 13.2/13.9File #: 69.28**WELDING INSPECTION REPORT****Resident Engineer:** Pursell, Gary**Address:** 333 Burma Road**City:** Oakland, CA 94607**Report No:** WIR-011949**Date Inspected:** 05-Feb-2010**Project Name:** SAS Superstructure**OSM Arrival Time:** 700**Prime Contractor:** American Bridge/Fluor Enterprises, a JV**OSM Departure Time:** 1900**Contractor:** Zhenhua Port Machinery Company, Ltd (ZPMC), Changxing Island **Location:** Shanghai, China

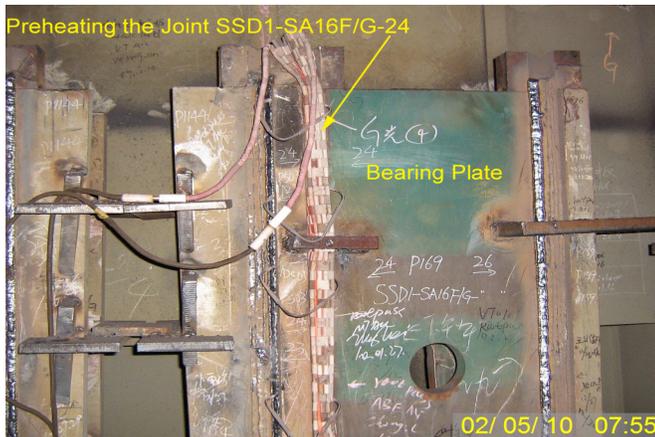
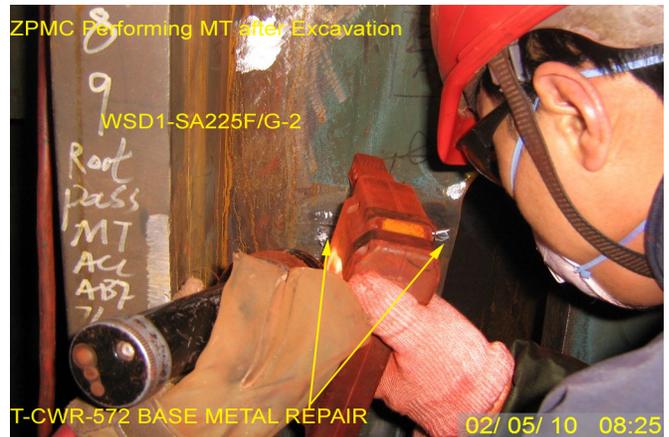
ZPMC performed Base metal repair of Bearing Plate located on Skin C (NSD1-SA17 -14, 16). The base metal repair areas were approximately 3mm depth and 50mm length at 2 random locations. The material is A 709M Grade 345 Non-SPCM. Welder is identified as 053829.ZPMC CWI is identified as Mr. Zhao Chen Sun. Welding was been performed against welding repair report T-WR3044. The welding variables recorded by QC appeared to comply with the WPS-345-SMAW-3G(3F)-Repair.

ZPMC performed Base metal repair of Bearing Plate located on Skin E (WSD1-SA225F/G -2). The base metal repair area is approximately 4mm depth and 120mm length. The material is A 709M Grade 345 Non-SPCM. Welder is identified as 066674.ZPMC CWI is identified as Mr. You Qi Guo. Welding was been performed against Critical Weld Repair report T-CWR572 and MT report number- T787-MT-7952. The welding variables recorded by QC appeared to comply with the WPS-345-SMAW-3G(3F)-Repair.

ZPMC performed Base metal repair of Bearing Plate located on Skin E (WSD1-SA225F/G -2). The base metal repair area is approximately 3mm depth and 45mm length. The material is A 709M Grade 345 Non-SPCM. Welder is identified as 066674.ZPMC CWI is identified as Mr. You Qi Guo. Welding was been performed against Critical Weld Repair report T-CWR573 and MT report number- T787-MT-7952. The welding variables recorded by QC appeared to comply with the WPS-345-SMAW-3G(3F)-Repair.
