Contract #: 04-0120F4Cty: SF/ALA Rte: 80 PM: 13.2/13.9File #: 69.28**WELDING INSPECTION REPORT****Resident Engineer:** Pursell, Gary**Address:** 333 Burma Road**City:** Oakland, CA 94607**Report No:** WIR-011989**Date Inspected:** 06-Feb-2010**Project Name:** SAS Superstructure**OSM Arrival Time:** 700**Prime Contractor:** American Bridge/Fluor Enterprises, a JV**OSM Departure Time:** 1900**Contractor:** Zhenhua Port Machinery Company, Ltd (ZPMC), Changxing Island **Location:** Shanghai, China**CWI Name:** Li Yang**CWI Present:** Yes No**Inspected CWI report:** Yes No N/A**Rod Oven in Use:** Yes No N/A**Electrode to specification:** Yes No N/A**Weld Procedures Followed:** Yes No N/A**Qualified Welders:** Yes No N/A**Verified Joint Fit-up:** Yes No N/A**Approved Drawings:** Yes No N/A**Approved WPS:** Yes No N/A**Delayed / Cancelled:** Yes No N/A**Bridge No:** 34-0006**Component:** OBG Segment**Summary of Items Observed:**

OBG # TRIAL ASSEMBLY YARD

WELDING INSPECTION REPORT

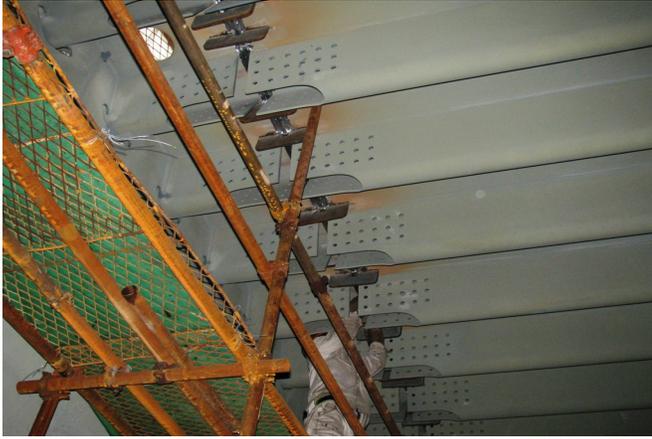
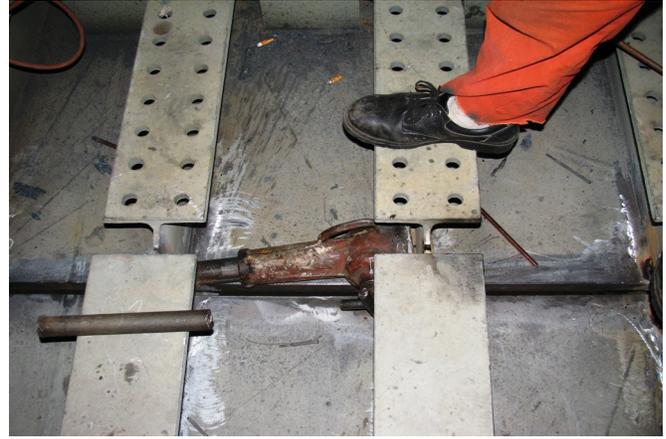
This QA inspector measured and recorded root gap and offset for below segments. Reports forwarded to team leader for further action

7BW-7CW

Please see the attached pictures below.
