Quality Assurance and Source Inspection

Contract #: 04-0120F4Cty: SF/ALA Rte: 80 PM: 13.2/13.9File #: 69.28**WELDING INSPECTION REPORT****Resident Engineer:** Pursell, Gary**Address:** 333 Burma Road**City:** Oakland, CA 94607**Report No:** WIR-012007**Date Inspected:** 08-Feb-2010**Project Name:** SAS Superstructure**OSM Arrival Time:** 700**Prime Contractor:** American Bridge/Fluor Enterprises, a JV**OSM Departure Time:** 1900**Contractor:** Zhenhua Port Machinery Company, Ltd (ZPMC), Changxing Island **Location:** Shanghai, China**CWI Name:** Mr. Wuzhi Chang/Mr. Li Yang**CWI Present:** Yes No**Inspected CWI report:** Yes No N/A**Rod Oven in Use:** Yes No N/A**Electrode to specification:** Yes No N/A**Weld Procedures Followed:** Yes No N/A**Qualified Welders:** Yes No N/A**Verified Joint Fit-up:** Yes No N/A**Approved Drawings:** Yes No N/A**Approved WPS:** Yes No N/A**Delayed / Cancelled:** Yes No N/A**Bridge No:** 34-0006**Component:** Orthotropic Box Girder (OBG)**Summary of Items Observed:**

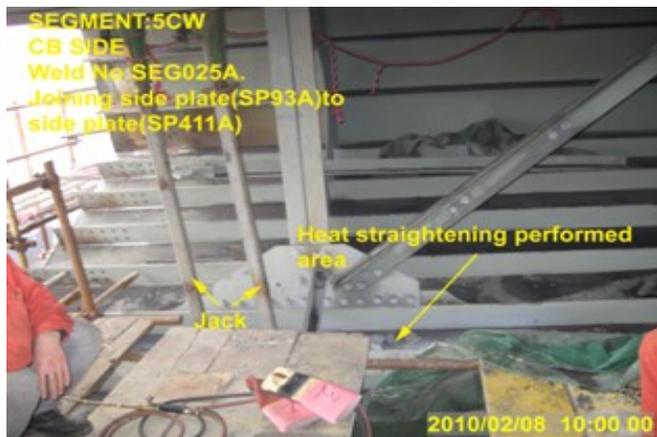
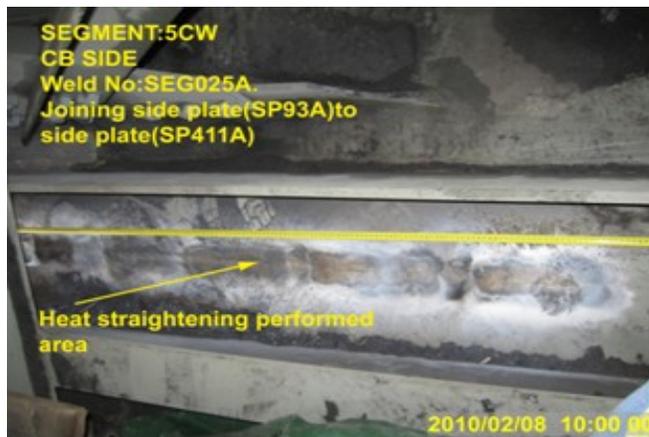
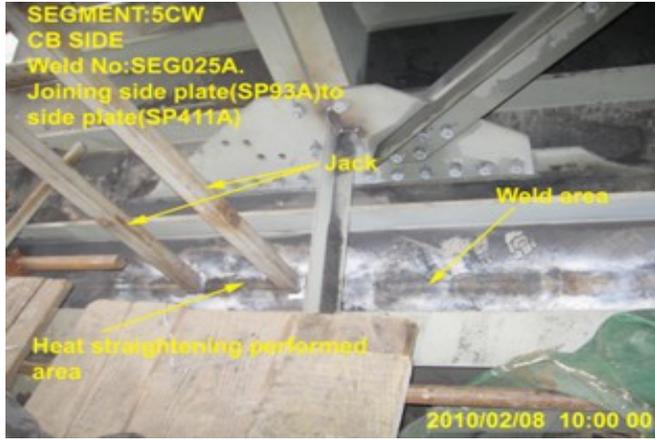
This QA Inspector observed ZPMC personnel performing Heat Straightening on weld joint no: SEG025A. The weld is connecting to Side plate (SP93A) and Side plate (SP411A) plate thickness is 18 mm. Against Caltrans Engineer approved document No: HSR (B)-350.Rev 0.

The attached photographs provide additional detail.
