**DEPARTMENT OF TRANSPORTATION**

Contract #: 04-0120F4Cty: SF/ALA Rte: 80 PM: 13.2/13.9File #: 69.28**WELDING INSPECTION REPORT****Resident Engineer:** Pursell, Gary**Address:** 333 Burma Road**City:** Oakland, CA 94607**Report No:** WIR-012281**Date Inspected:** 25-Feb-2010**Project Name:** SAS Superstructure**OSM Arrival Time:** 645**Prime Contractor:** American Bridge/Fluor Enterprises, a JV**OSM Departure Time:** 1845**Contractor:** Zhenhua Port Machinery Company, Ltd (ZPMC), Changxing Island **Location:** Shanghai, China**CWI Name:** Chen Xi, Li Jia.**CWI Present:** Yes No**Inspected CWI report:** Yes No N/A**Rod Oven in Use:** Yes No N/A**Electrode to specification:** Yes No N/A**Weld Procedures Followed:** Yes No N/A**Qualified Welders:** Yes No N/A**Verified Joint Fit-up:** Yes No N/A**Approved Drawings:** Yes No N/A**Approved WPS:** Yes No N/A**Delayed / Cancelled:** Yes No N/A**Bridge No:** 34-0006**Component:** Orthotropic Box Girder (OBG)**Summary of Items Observed:**

# WELDING INSPECTION REPORT

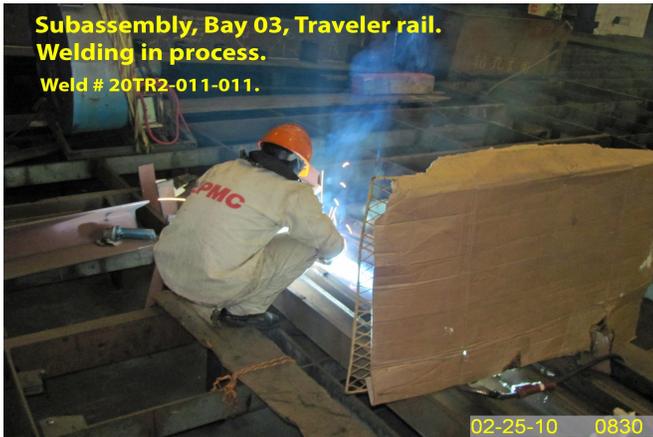
Subassembly, Bay 03, Traveler rail.

FCAW welding of weld joint 20TR2-011-011 & 20TR2-013-011; located on Subassembly, Bay 03. Welder is identified as 044824; ZPMC Quality Control Inspector (QC) is identified as Chen Xi. The welding variables recorded by Quality Control Inspector (QC) appeared to comply with the Applicable WPS: WPS-B-T-2231-TC-U5-F. The attached photographs provide additional detail.

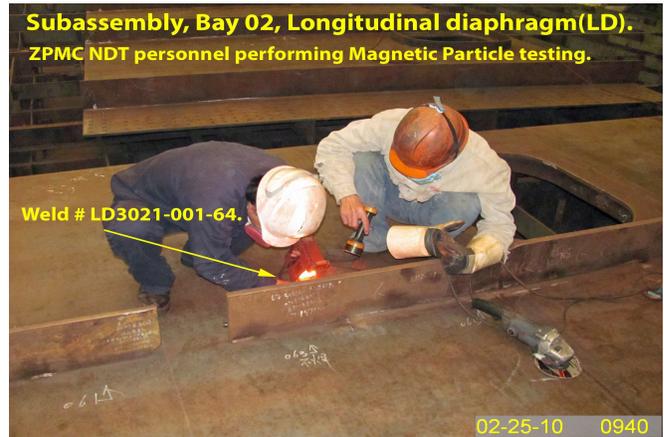
Subassembly, Bay 02, Longitudinal Diaphragm.

During random Inprocess Visual inspection this QA inspector observed ZPMC & AB/F NDT personal performing Magnetic Particle Testing (MT) on weld identified as LD3021-001-064, 037. The attached photographs provide additional detail.
