Contract #: 04-0120F4Cty: SF/ALA Rte: 80 PM: 13.2/13.9File #: 69.28**WELDING INSPECTION REPORT****Resident Engineer:** Pursell, Gary**Address:** 333 Burma Road**City:** Oakland, CA 94607**Report No:** WIR-012359**Date Inspected:** 10-Feb-2010**Project Name:** SAS Superstructure**OSM Arrival Time:** 645**Prime Contractor:** American Bridge/Fluor Enterprises, a JV**OSM Departure Time:** 1845**Contractor:** Zhenhua Port Machinery Company, Ltd (ZPMC), Changxing Island **Location:** Shanghai, China**CWI Name:** Chen Xi/Liu Fa Wen**CWI Present:** Yes No**Inspected CWI report:** Yes No N/A**Rod Oven in Use:** Yes No N/A**Electrode to specification:** Yes No N/A**Weld Procedures Followed:** Yes No N/A**Qualified Welders:** Yes No N/A**Verified Joint Fit-up:** Yes No N/A**Approved Drawings:** Yes No N/A**Approved WPS:** Yes No N/A**Delayed / Cancelled:** Yes No N/A**Bridge No:** 34-0006**Component:** OBG Components**Summary of Items Observed:**

WELDING INSPECTION REPORT

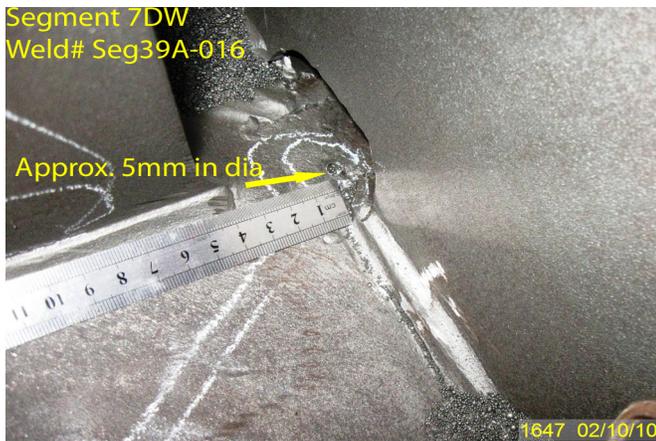
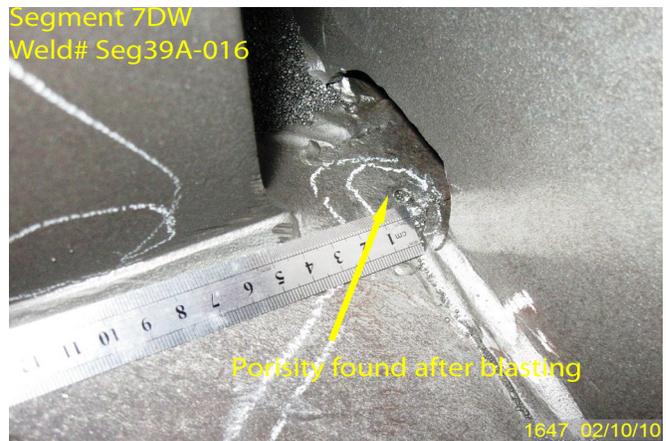
Segment 7DW

This QA Inspector performed a preliminary random visual inspection after the grit blast of the internal components of the deck panel, floor beams and corner assemblies of this segment. Areas of visual weld defects that will require welding were taped and will be repaired after the coating is applied. ZPMC QC personnel are aware of these areas and were present during the inspection.

For further information, please see attached picture.
