Contract #: 04-0120F4Cty: SF/ALA Rte: 80 PM: 13.2/13.9File #: 69.28**WELDING INSPECTION REPORT****Resident Engineer:** Pursell, Gary**Address:** 333 Burma Road**City:** Oakland, CA 94607**Report No:** WIR-012392**Date Inspected:** 04-Feb-2010**Project Name:** SAS Superstructure**OSM Arrival Time:** 645**Prime Contractor:** American Bridge/Fluor Enterprises, a JV**OSM Departure Time:** 1845**Contractor:** Zhenhua Port Machinery Company, Ltd (ZPMC), Changxing Island **Location:** Shanghai, China**CWI Name:** As identified below**CWI Present:** Yes No**Inspected CWI report:** Yes No N/A**Rod Oven in Use:** Yes No N/A**Electrode to specification:** Yes No N/A**Weld Procedures Followed:** Yes No N/A**Qualified Welders:** Yes No N/A**Verified Joint Fit-up:** Yes No N/A**Approved Drawings:** Yes No N/A**Approved WPS:** Yes No N/A**Delayed / Cancelled:** Yes No N/A**Bridge No:** 34-0006**Component:** OBG**Summary of Items Observed:**

WELDING INSPECTION REPORT

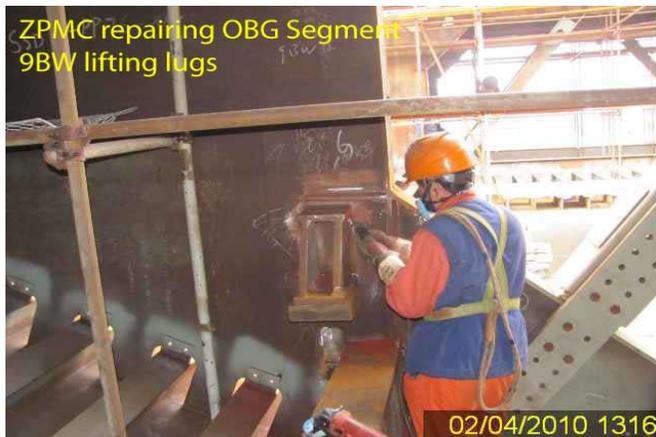
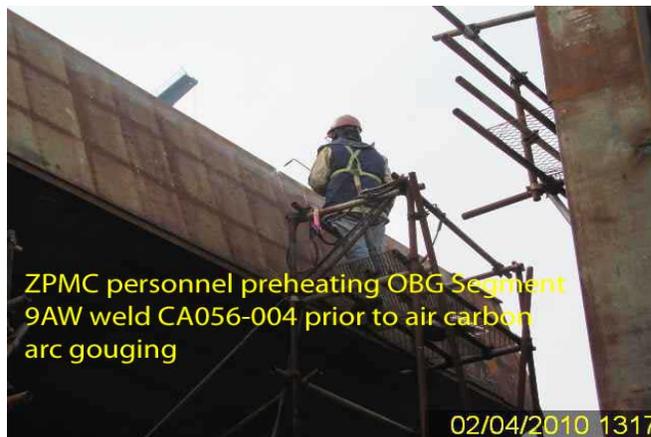
This QA Inspector observed the following work in progress: Shielded Metal Arc Welding (SMAW) of OBG Segment 8CE side panel WT stiffener Complete Joint Penetration (CJP) weld, SP541-001-018. ZPMC welder was identified as 043661. ZPMC CWI was identified as Zhu Zhong Hai. The WT stiffener weld was removed and rewelded to correct misalignment. The welding appeared to be in conformance with welding procedure specification, WPS-345-SMAW-3G(3F)-Repair and Weld Repair Report B-WR10632

Caltrans QA inspector observed: ZPMC personnel performing air carbon arc gouging on OBG Segment 9AW corner assembly weld CA056-044 to remove indications found with Ultrasonic Testing. ZPMC personnel appear to be performing repair work as per Critical Weld Repair Report # B-CWR 1199.

ZPMC QC performing MT on Segment 9BW FL3 manway exterior.

Caltrans Quality Assurance (QA) Inspectors performed random visual inspection of OBG segment 7EW Lower section between the east side of panel point 59 and panel point 60.5. Areas requiring light grinding were marked for ZPMC personnel. The location of areas requiring weld repair were recorded and placed on on the punchlist for future repair.
