DEPARTMENT OF TRANSPORTATION

Contract #: 04-0120F4Cty: SF/ALA Rte: 80 PM: 13.2/13.9File #: 69.28**WELDING INSPECTION REPORT****Resident Engineer:** Pursell, Gary**Address:** 333 Burma Road**City:** Oakland, CA 94607**Report No:** WIR-012402**Date Inspected:** 23-Feb-2010**Project Name:** SAS Superstructure**OSM Arrival Time:** 1900**Prime Contractor:** American Bridge/Fluor Enterprises, a JV**OSM Departure Time:** 700**Contractor:** Zhenhua Port Machinery Company, Ltd (ZPMC), Changxing Island **Location:** Shanghai, China**CWI Name:** See Below**CWI Present:** Yes No**Inspected CWI report:** Yes No N/A**Rod Oven in Use:** Yes No N/A**Electrode to specification:** Yes No N/A**Weld Procedures Followed:** Yes No N/A**Qualified Welders:** Yes No N/A**Verified Joint Fit-up:** Yes No N/A**Approved Drawings:** Yes No N/A**Approved WPS:** Yes No N/A**Delayed / Cancelled:** Yes No N/A**Bridge No:** 34-0006**Component:** OBG and Tower**Summary of Items Observed:**

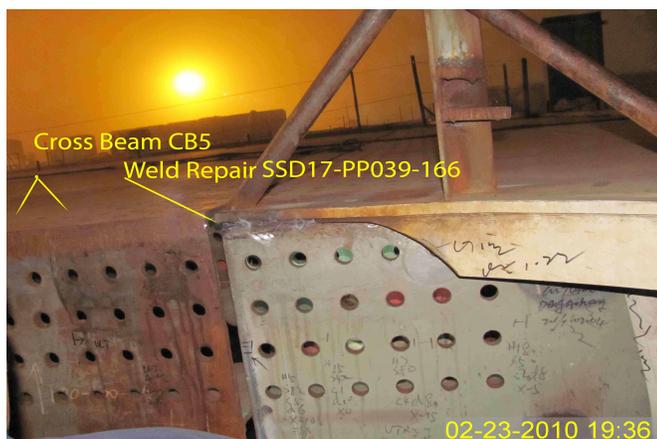
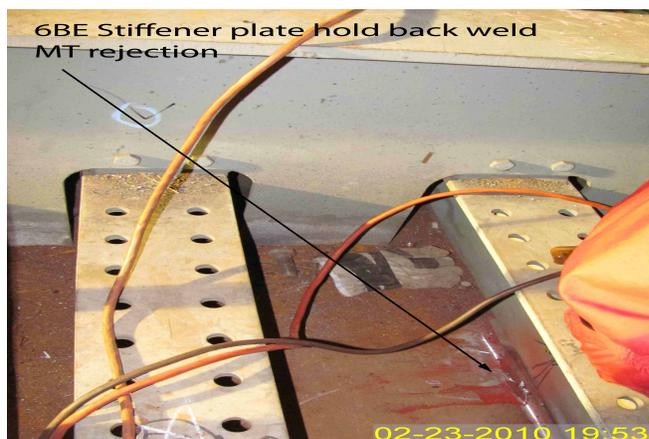
This QA Inspector observed ZPMC welder Mr. Zhou Songsong, stencil 068091 appears to have used the shielded metal arc process earlier in the shift to make weld repairs to various stiffener plate hold back welds at OBG segment 6BE adjacent to where segment 6CE is to be attached. This QA Inspector did not observe any welding being performed and Mr. Songsong appears to be certified to perform these weld repairs. This QA Inspector asked ZPMC CWI Mr. Li Yang if he was aware that Mr. Zhou Songsong has been performing weld repairs at OBG segment 6BE and Mr. Li Yang said he had not been told of any welding being performed at this location. Mr. Li Yang said the magnetic particle inspector has identified a crack at the hold back weld on the 8th stiffener plate on the bottom plate, as measured from the cross beam side of the OBG, and Caltrans engineering approval will be obtained prior to making a weld repair at this location.
