DEPARTMENT OF TRANSPORTATION

Contract #: 04-0120F4Cty: SF/ALA Rte: 80 PM: 13.2/13.9File #: 69.28**WELDING INSPECTION REPORT****Resident Engineer:** Pursell, Gary**Address:** 333 Burma Road**City:** Oakland, CA 94607**Report No:** WIR-012549**Date Inspected:** 06-Mar-2010**Project Name:** SAS Superstructure**OSM Arrival Time:** 700**Prime Contractor:** American Bridge/Fluor Enterprises, a JV**OSM Departure Time:** 1900**Contractor:** Zhenhua Port Machinery Company, Ltd (ZPMC), Changxing Island **Location:** Shanghai, China

CWI Name:	Mr. Du zhi qun/ Mr. Gong Liang			CWI Present:	Yes	No	
Inspected CWI report:	Yes	No	N/A	Rod Oven in Use:	Yes	No	N/A
Electrode to specification:	Yes	No	N/A	Weld Procedures Followed:	Yes	No	N/A
Qualified Welders:	Yes	No	N/A	Verified Joint Fit-up:	Yes	No	N/A
Approved Drawings:	Yes	No	N/A	Approved WPS:	Yes	No	N/A
				Delayed / Cancelled:	Yes	No	N/A
Bridge No:	34-0006			Component:	Tower

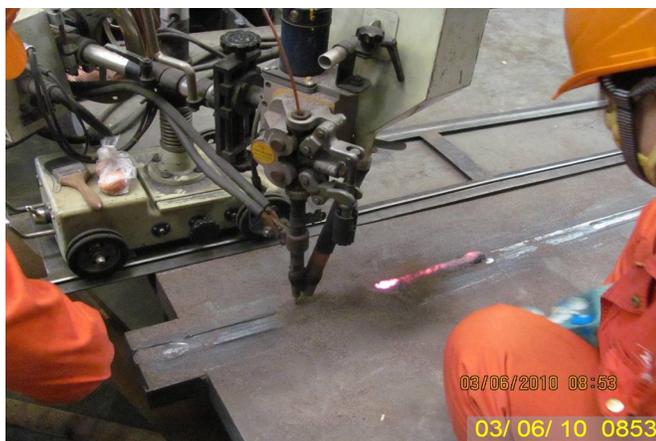
1. This QA inspector, Baskar Govindarajan, observed, ZPMC qualified welding personnel identified as 207745 perform SAW welding on, Grillage plate of North tower, and weld joint identified as NSD1-TL5-3B-F-6B. ZPMC CWI Identified as Mr. Du Zhi Qun. The welding parameters as measured using QC's calibrated instruments appeared to be in general compliance with WPS-B-T-3221-B-U3C-S-1. (Photo attached)

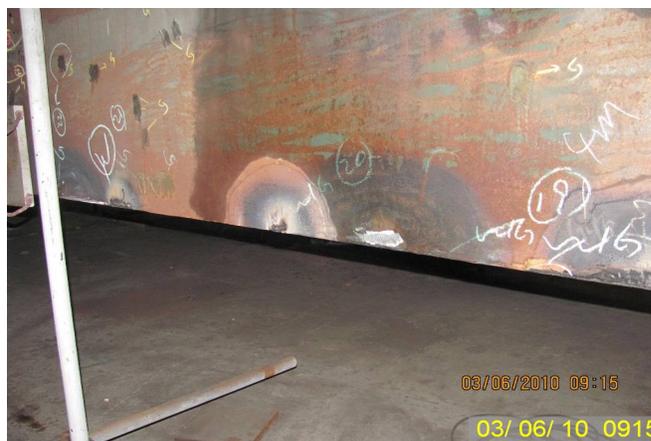
2. This QA inspector, Baskar Govindarajan, observed, ZPMC qualified welding personnel identified as 052493 perform SMAW Repair welding on, BC Corner of North tower, Lift 4 and weld joint identified as NSTL4-3B/L-4A. ZPMC CWI Identified as Mr. Gong liang zhu. The welding parameters as measured using QC's calibrated instruments appeared to be in general compliance with WPS-345-SMAW- 2G (2F)-Repair. (Photo attached)
