DEPARTMENT OF TRANSPORTATION

Quality Assurance and Source Inspection

Contract #: 04-0120F4Cty: SF/ALA Rte: 80 PM: 13.2/13.9File #: 69.28**WELDING INSPECTION REPORT****Resident Engineer:** Pursell, Gary**Address:** 333 Burma Road**City:** Oakland, CA 94607**Report No:** WIR-013160**Date Inspected:** 17-Mar-2010**Project Name:** SAS Superstructure**OSM Arrival Time:** 700**Prime Contractor:** American Bridge/Fluor Enterprises, a JV**OSM Departure Time:** 1900**Contractor:** Zhenhua Port Machinery Company, Ltd (ZPMC), Changxing Island **Location:** Shanghai, China**CWI Name:** Li Yang**CWI Present:** Yes No**Inspected CWI report:** Yes No N/A**Rod Oven in Use:** Yes No N/A**Electrode to specification:** Yes No N/A**Weld Procedures Followed:** Yes No N/A**Qualified Welders:** Yes No N/A**Verified Joint Fit-up:** Yes No N/A**Approved Drawings:** Yes No N/A**Approved WPS:** Yes No N/A**Delayed / Cancelled:** Yes No N/A**Bridge No:** 34-0006**Component:** OBG Segment**Summary of Items Observed:**

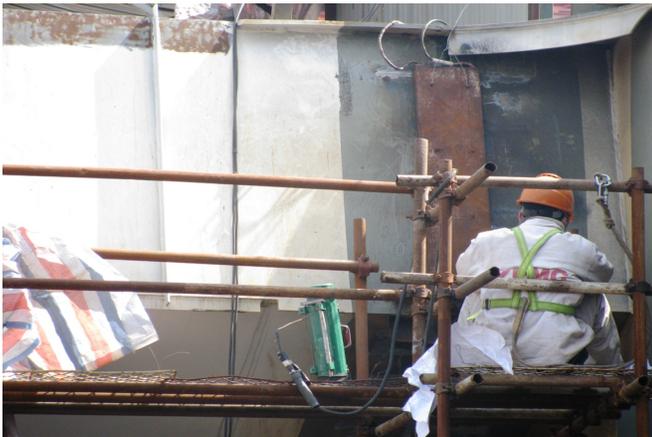
Welding of weld joint –010 located on PCMK OBE7A, Edge panel. Welder is identified as 048659. ZPMC CWI is identified as Li Yang. The welding variables recorded by QC appeared to comply with the WPS-B-P-2213-B-U2-FCM-1.

Please see the attached picture below
