Contract #: 04-0120F4Cty: SF/ALA Rte: 80 PM: 13.2/13.9File #: 69.28**WELDING INSPECTION REPORT****Resident Engineer:** Pursell, Gary**Address:** 333 Burma Road**City:** Oakland, CA 94607**Report No:** WIR-013029**Date Inspected:** 12-Apr-2010**Project Name:** SAS Superstructure**OSM Arrival Time:** 700**Prime Contractor:** American Bridge/Fluor Enterprises, a JV**OSM Departure Time:** 1900**Contractor:** Zhenhua Port Machinery Company, Ltd (ZPMC), Changxing Island **Location:** Shanghai, China**CWI Name:** Chen Xi**CWI Present:** Yes No**Inspected CWI report:** Yes No N/A**Rod Oven in Use:** Yes No N/A**Electrode to specification:** Yes No N/A**Weld Procedures Followed:** Yes No N/A**Qualified Welders:** Yes No N/A**Verified Joint Fit-up:** Yes No N/A**Approved Drawings:** Yes No N/A**Approved WPS:** Yes No N/A**Delayed / Cancelled:** Yes No N/A**Bridge No:** 34-0006**Component:** OBG**Summary of Items Observed:**

On this day CALTRANS OSM Quality Assurance Inspector (QA) Shailesh Wadkar was present during the times noted above for observations relative to the fabrication of the Self Anchored Suspension (SAS) Superstructure being performed by Zhenhua Port Machinery Company (ZPMC) a

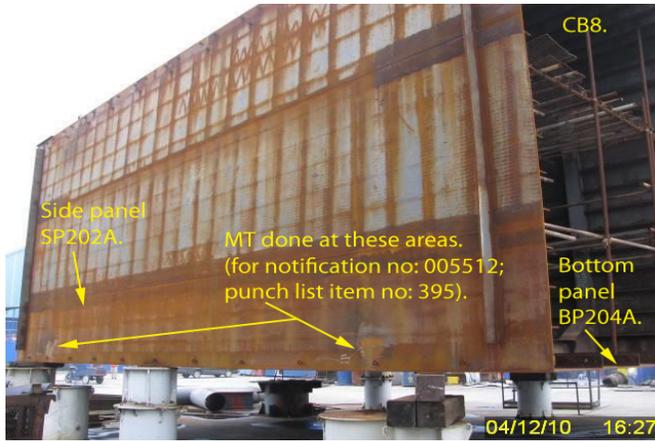
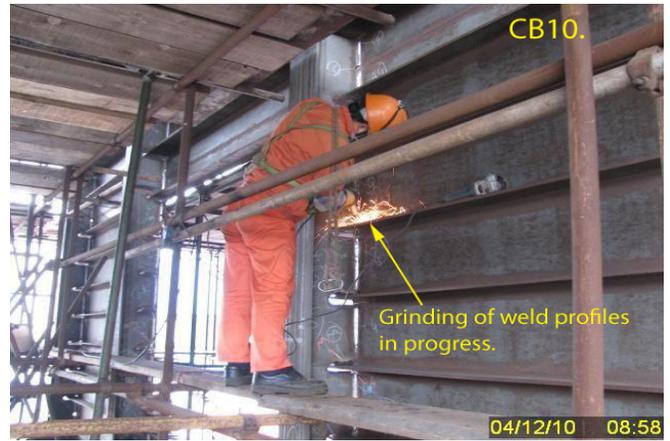
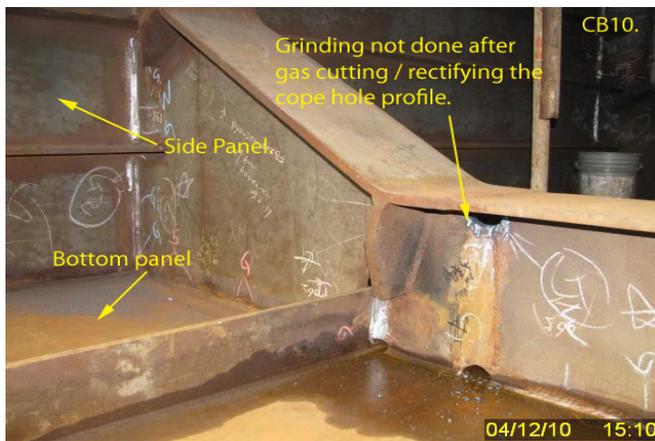
This QA Inspector observed the following work in progress:
ZPMC personnel doing grinding of weld profiles of the welds of this CB. ZPMC QC was identified as Mr. Chen Xi & ABF QA was identified as Cao Hui Zhao. This QA Inspector did random visual inspection of the welds after grinding. This QA Inspector observed that some of the cope holes do not comply with the contract documents and had marked such locations in question to the Contractors QC to inspect and evaluate. Refer attached photos for reference.

This QA inspector performed Magnetic Particle Testing (MT) of base metal repaired area on side panel and bottom panel (identified as Seismic Performance Critical Member – SPCM material) of CB8. The areas being repaired were damaged while removing temporary lifting lugs. The affected panels are identified as side panel SP202A & bottom panel BP204A. This repaired area is 100% MT tested by ZPMC Quality Control (QC) personnel. Refer attached photos for details.
