**DEPARTMENT OF TRANSPORTATION**

Contract #: 04-0120F4Cty: SF/ALA Rte: 80 PM: 13.2/13.9File #: 69.28**WELDING INSPECTION REPORT****Resident Engineer:** Pursell, Gary**Address:** 333 Burma Road**City:** Oakland, CA 94607**Report No:** WIR-013068**Date Inspected:** 10-Apr-2010**Project Name:** SAS Superstructure**OSM Arrival Time:** 700**Prime Contractor:** American Bridge/Fluor Enterprises, a JV**OSM Departure Time:** 1900**Contractor:** Zhenhua Port Machinery Company, Ltd (ZPMC), Changxing Island **Location:** Shanghai, China**CWI Name:** Mr. Zhu Tian Shu**CWI Present:** Yes No**Inspected CWI report:** Yes No N/A**Rod Oven in Use:** Yes No N/A**Electrode to specification:** Yes No N/A**Weld Procedures Followed:** Yes No N/A**Qualified Welders:** Yes No N/A**Verified Joint Fit-up:** Yes No N/A**Approved Drawings:** Yes No N/A**Approved WPS:** Yes No N/A**Delayed / Cancelled:** Yes No N/A**Bridge No:** 34-0006**Component:** Orthotropic Box Girder (OBG)**Summary of Items Observed:**

## WELDING INSPECTION REPORT

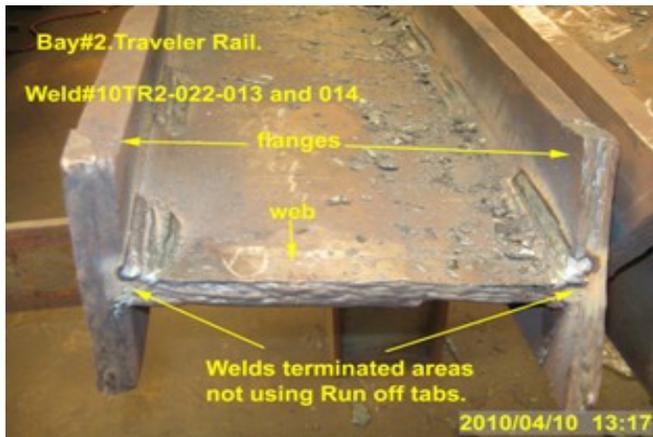
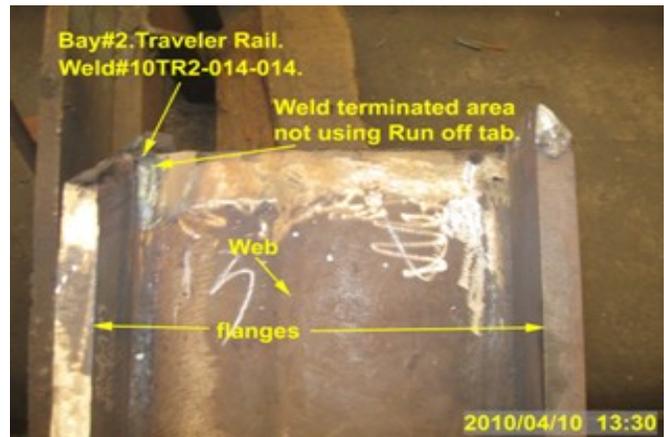
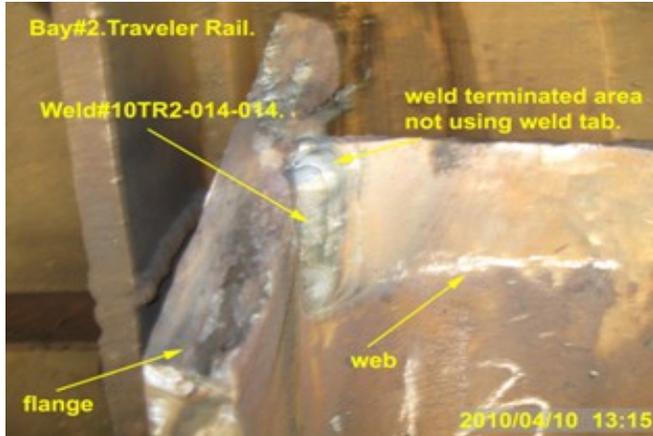
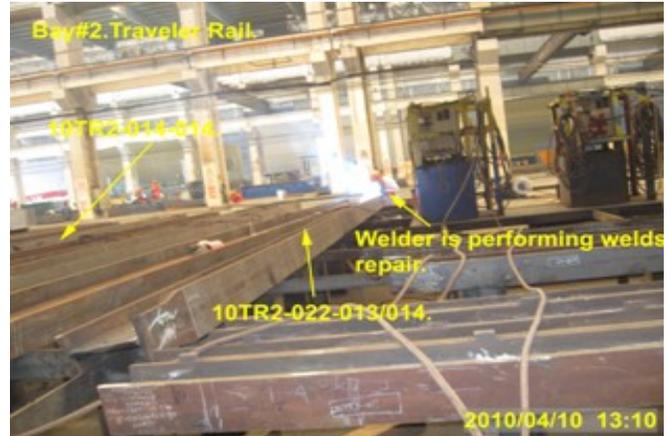
During Quality Assurance random in-process observations of the fabrication of Traveler Rail (TR) 10TR2-014 and 10TR2-022, this Caltrans Quality Assurance (QA) inspector discovered the following issue:

- Complete Joint Penetration (CJP) Repair welding was performing without using run-off tabs.
- The use of run-off tabs is specified in AWS D1.5 2002 section 3.12.1.
- The member is identified as a TR, 10TR2-014 and 10TR2-022.
- The welds are a CJP, T joints identified as 10TR2-014-014 and 10TR2-022-013/014.
- The Repair welding was performing against the Welding Repair Report (WRR): B-WR11789 Rev No: 0 & B-WR11784/85 Rev No: 0 respectively and Ultrasonic Testing (UT) Report No: B787-UT-10913R1 and B787-UT-10916R1-2 respectively.
- The welds are joining to the Traveler Rail web to flanges.
- OBG TR-10TR2-014 and 10TR2-022 are located in the Bay-2.

Applicable reference: American Welding Society (AWS) D1.5 2002 section 3.12.1 “Welds shall be terminated at the end of a joint in a manner that will ensure sound welds. Whenever possible, this shall be done using weld tabs (extension bars and run off plates) placed in a manner that will duplicate the joint detail being welded”.

This QA generated an incident report on this date for the above issue, for further details see attached photographs and an incident report.
