Contract #: 04-0120F4Cty: SF/ALA Rte: 80 PM: 13.2/13.9File #: 69.28**WELDING INSPECTION REPORT****Resident Engineer:** Pursell, Gary**Address:** 333 Burma Road**City:** Oakland, CA 94607**Report No:** WIR-013089**Date Inspected:** 16-Apr-2010**Project Name:** SAS Superstructure**OSM Arrival Time:** 700**Prime Contractor:** American Bridge/Fluor Enterprises, a JV**OSM Departure Time:** 1700**Contractor:** Zhenhua Port Machinery Company, Ltd (ZPMC), Changxing Island **Location:** Shanghai, China**CWI Name:** Li Yang**CWI Present:** Yes No**Inspected CWI report:** Yes No N/A**Rod Oven in Use:** Yes No N/A**Electrode to specification:** Yes No N/A**Weld Procedures Followed:** Yes No N/A**Qualified Welders:** Yes No N/A**Verified Joint Fit-up:** Yes No N/A**Approved Drawings:** Yes No N/A**Approved WPS:** Yes No N/A**Delayed / Cancelled:** Yes No N/A**Bridge No:** 34-0006**Component:** Orthotropic Box Girder (OBG)**Summary of Items Observed:**

OBG # TRIAL ASSEMBLY YARD

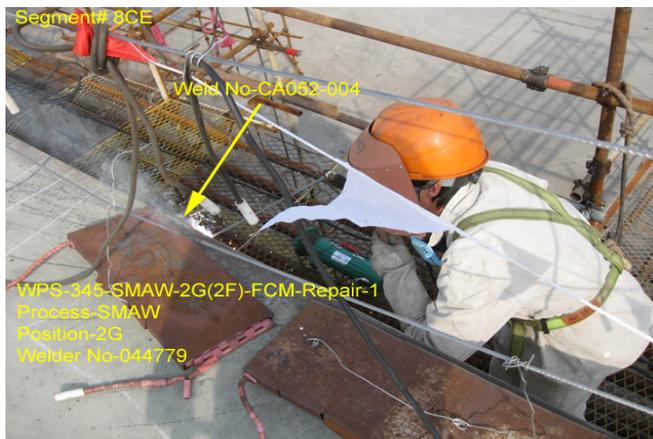
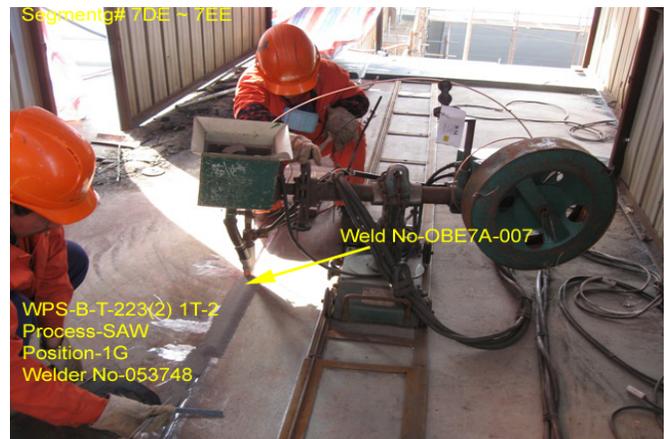
This QA inspector observed, ZPMC qualified welding personnel identified as 044779 perform Shielded Metal Arc Welding (SMAW), weld joint identified as CA052-004; The Critical Welding Repair Report (CWRR) was B-CWR1406. ZPMC QC is identified as Mr. Wang Li Yang. The welding parameters measured using QC's calibrated instrument appeared to be in general compliance with WPS-345-SMAW-2G (2F)-FCM-Repair-1. See the attached

Below Photo.
