Contract #: 04-0120F4Cty: SF/ALA Rte: 80 PM: 13.2/13.9File #: 69.28**WELDING INSPECTION REPORT****Resident Engineer:** Pursell, Gary**Address:** 333 Burma Road**City:** Oakland, CA 94607**Report No:** WIR-013093**Date Inspected:** 10-Apr-2010**Project Name:** SAS Superstructure**OSM Arrival Time:** 700**Prime Contractor:** American Bridge/Fluor Enterprises, a JV**OSM Departure Time:** 1900**Contractor:** Zhenhua Port Machinery Company, Ltd (ZPMC), Changxing Island **Location:** Shanghai, China**CWI Name:** LI Yang**CWI Present:** Yes No**Inspected CWI report:** Yes No N/A**Rod Oven in Use:** Yes No N/A**Electrode to specification:** Yes No N/A**Weld Procedures Followed:** Yes No N/A**Qualified Welders:** Yes No N/A**Verified Joint Fit-up:** Yes No N/A**Approved Drawings:** Yes No N/A**Approved WPS:** Yes No N/A**Delayed / Cancelled:** Yes No N/A**Bridge No:** 34-0006**Component:** Orthotropic Box Girder (OBG)**Summary of Items Observed:**

OBG # TRIAL ASSEMBLY YARD

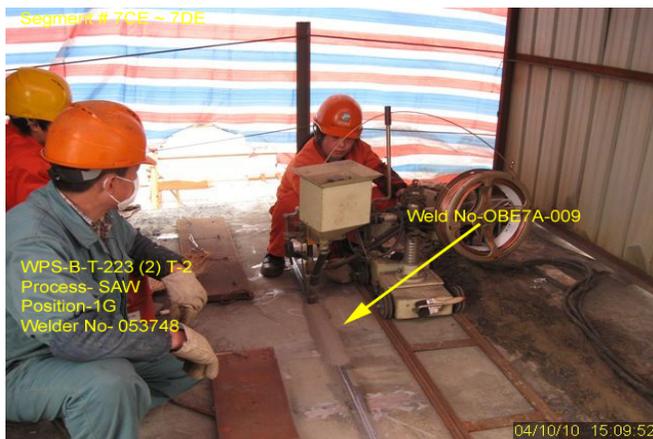
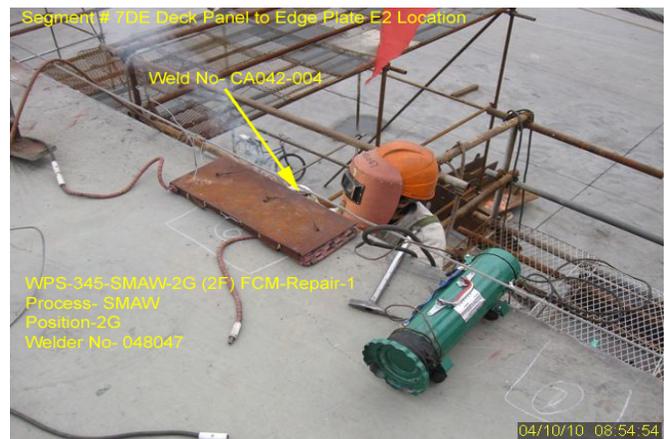
This QA inspector observed, ZPMC qualified welding personnel identified as 048047 perform Shielded Metal Arc Welding (SMAW) for weld connecting Deck panel to Edge plate E2 Location, weld joint identified as CA042-004; The Critical Welding Repair Report (CWRR) was B-CWR1378. ZPMC QC is identified as Mr. The welding parameters measured using QC's calibrated instrument appeared to be in general compliance with WPS-345-SMAW-2G (2F)-FCM-Repair-1. See the attached Photo.

This QA inspector observed, ZPMC qualified welding personnel identified as 045221 perform Shielded Metal Arc Welding (SMAW) for weld connecting Deck panel to Edge plate W2 Location, weld joint identified as CA043-004; The Critical Welding Repair Report (CWRR) was B-CWR1377. ZPMC QC is identified as Mr. Wang Xiang Pin. The welding parameters measured using QC's calibrated instrument appeared to be in general compliance with WPS-345-SMAW-2G (2F)-FCM-Repair-1. See the attached Photo.

This QA inspector observed, ZPMC qualified welding personnel identified as 053748 perform Submerged Arc Welding (SAW), weld joint identified as OBE7A-009, ZPMC CWI identified as Mr. Wang Li Yang. The welding parameters measured using QC's calibrated instrument appeared to be in general compliance with WPS-B-T-223(2) T-2. See the attached below Photo.
