DEPARTMENT OF TRANSPORTATION

Contract #: 04-0120F4Cty: SF/ALA Rte: 80 PM: 13.2/13.9File #: 69.28**WELDING INSPECTION REPORT****Resident Engineer:** Pursell, Gary**Address:** 333 Burma Road**City:** Oakland, CA 94607**Report No:** WIR-013126**Date Inspected:** 09-Apr-2010**Project Name:** SAS Superstructure**OSM Arrival Time:** 700**Prime Contractor:** American Bridge/Fluor Enterprises, a JV**OSM Departure Time:** 900**Contractor:** Zhenhua Port Machinery Company, Ltd (ZPMC), Changxing Island **Location:** Shanghai, China**CWI Name:****CWI Present:**

Bridge No: 34-0006**Component:** OBG Trial Assembly**Summary of Items Observed:**

Rotation Capacity Test Witness

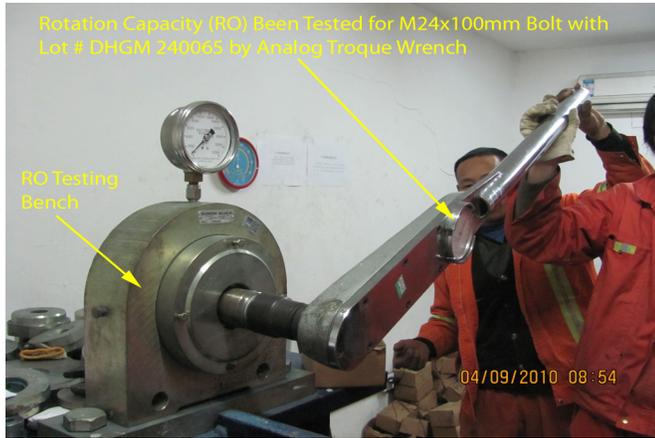
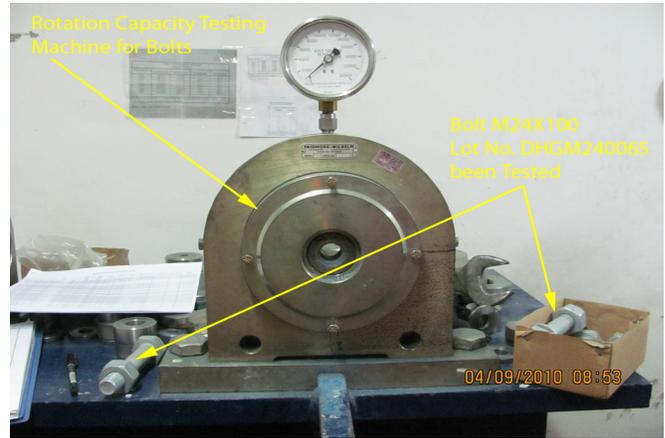
This QA Inspector witnessed the Rotation Capacity Test for the following at Bolt Testing Laboratory located at Bay No. 11.

Bolt Size: M24 x 100 mm

Temperature and Humidity inside the Laboratory: 16 Degree Centigrade and 60% RH.

Torque Value observed as: 960N-m, 1040 N-m and 1040 N-m.

The tension test performed for lot observed to be in general compliance with requirements.
