**DEPARTMENT OF TRANSPORTATION**

Contract #: 04-0120F4Cty: SF/ALA Rte: 80 PM: 13.2/13.9File #: 69.28**WELDING INSPECTION REPORT****Resident Engineer:** Pursell, Gary**Address:** 333 Burma Road**City:** Oakland, CA 94607**Report No:** WIR-013144**Date Inspected:** 08-Apr-2010**Project Name:** SAS Superstructure**OSM Arrival Time:** 700**Prime Contractor:** American Bridge/Fluor Enterprises, a JV**OSM Departure Time:** 1900**Contractor:** Zhenhua Port Machinery Company, Ltd (ZPMC), Changxing Island **Location:** Shanghai, China**CWI Name:** Li Yang**CWI Present:** Yes No**Inspected CWI report:** Yes No N/A**Rod Oven in Use:** Yes No N/A**Electrode to specification:** Yes No N/A**Weld Procedures Followed:** Yes No N/A**Qualified Welders:** Yes No N/A**Verified Joint Fit-up:** Yes No N/A**Approved Drawings:** Yes No N/A**Approved WPS:** Yes No N/A**Delayed / Cancelled:** Yes No N/A**Bridge No:** 34-0006**Component:** OBG Segment**Summary of Items Observed:**

**OBG # TRIAL ASSEMBLY YARD**

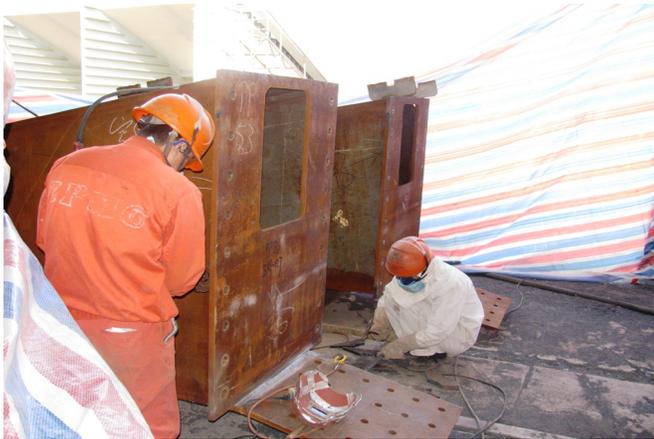
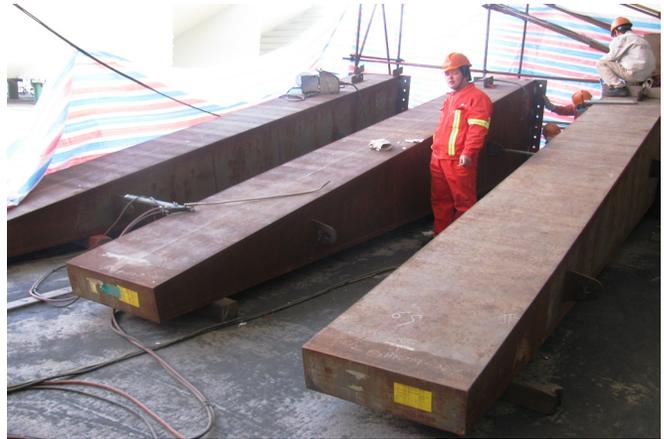
Welding of weld joint – 007 located on PCMK BK001-026, Bike path cantilever base plate located at PP 51. Welder is identified as 220069. ZPMC CWI is identified as Li Yang. The welding variables recorded by QC appeared to comply with the WPS-B-T-2233-Tc-U4b-F.

Welding of weld joint – 009 located on PCMK BK001-026, Bike path cantilever base plate located at PP 51. Welder is identified as 220069. ZPMC CWI is identified as Li Yang. The welding variables recorded by QC appeared to comply with the WPS-B-T-2231-Tc-U4b-F.

For further information, Please see the attached pictures below.
