**DEPARTMENT OF TRANSPORTATION**

Contract #: 04-0120F4Cty: SF/ALA Rte: 80 PM: 13.2/13.9File #: 69.28**WELDING INSPECTION REPORT****Resident Engineer:** Pursell, Gary**Address:** 333 Burma Road**City:** Oakland, CA 94607**Report No:** WIR-013302**Date Inspected:** 07-Apr-2010**Project Name:** SAS Superstructure**OSM Arrival Time:** 700**Prime Contractor:** American Bridge/Fluor Enterprises, a JV**OSM Departure Time:** 1900**Contractor:** Zhenhua Port Machinery Company, Ltd (ZPMC), Changxing Island **Location:** Shanghai, China**CWI Name:** Yu Dong Ping, Tu Jun**CWI Present:** Yes No**Inspected CWI report:** Yes No N/A**Rod Oven in Use:** Yes No N/A**Electrode to specification:** Yes No N/A**Weld Procedures Followed:** Yes No N/A**Qualified Welders:** Yes No N/A**Verified Joint Fit-up:** Yes No N/A**Approved Drawings:** Yes No N/A**Approved WPS:** Yes No N/A**Delayed / Cancelled:** Yes No N/A**Bridge No:** 34-0006**Component:** Tower**Summary of Items Observed:**

## WELDING INSPECTION REPORT

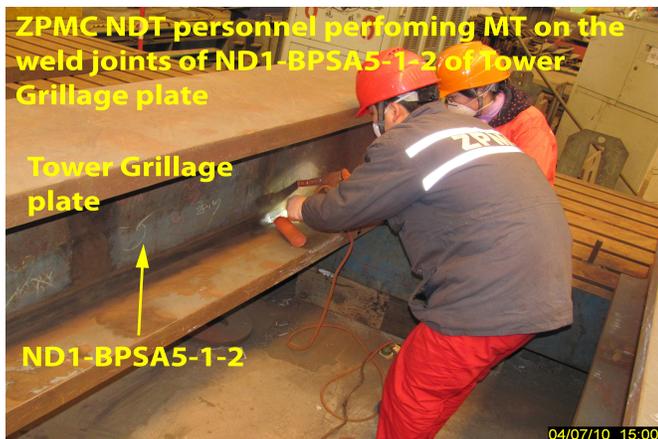
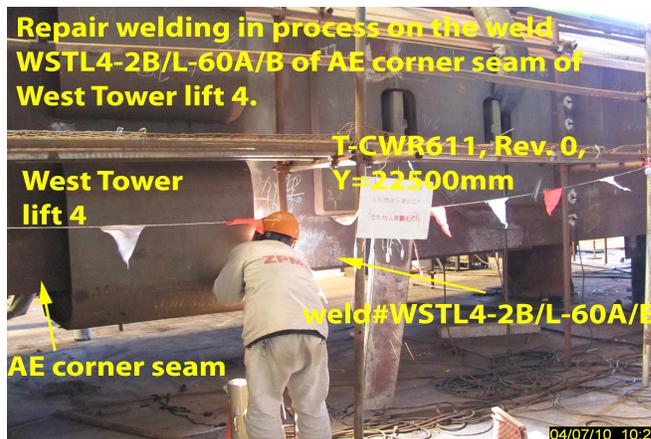
This QA Inspector witnessed Magnetic Particle Testing (MT) performed by ZPMC NDT personnel on the weld joints of ND1-BPSA5-1-2 of Tower Grillage plate. The attached photographs provide additional detail.
