DEPARTMENT OF TRANSPORTATION

Quality Assurance and Source Inspection

Contract #: 04-0120F4Cty: SF/ALA Rte: 80 PM: 13.2/13.9File #: 69.28**WELDING INSPECTION REPORT****Resident Engineer:** Pursell, Gary**Address:** 333 Burma Road**City:** Oakland, CA 94607**Report No:** WIR-013771**Date Inspected:** 08-Apr-2010**Project Name:** SAS Superstructure**OSM Arrival Time:** 700**Prime Contractor:** American Bridge/Fluor Enterprises, a JV**OSM Departure Time:** 1900**Contractor:** Zhenhua Port Machinery Company, Ltd (ZPMC), Changxing Island **Location:** Shanghai, China**CWI Name:** Gong Wei**CWI Present:** Yes No**Inspected CWI report:** Yes No N/A**Rod Oven in Use:** Yes No N/A**Electrode to specification:** Yes No N/A**Weld Procedures Followed:** Yes No N/A**Qualified Welders:** Yes No N/A**Verified Joint Fit-up:** Yes No N/A**Approved Drawings:** Yes No N/A**Approved WPS:** Yes No N/A**Delayed / Cancelled:** Yes No N/A**Bridge No:** 34-0006**Component:** OBG COMPONENT**Summary of Items Observed:**

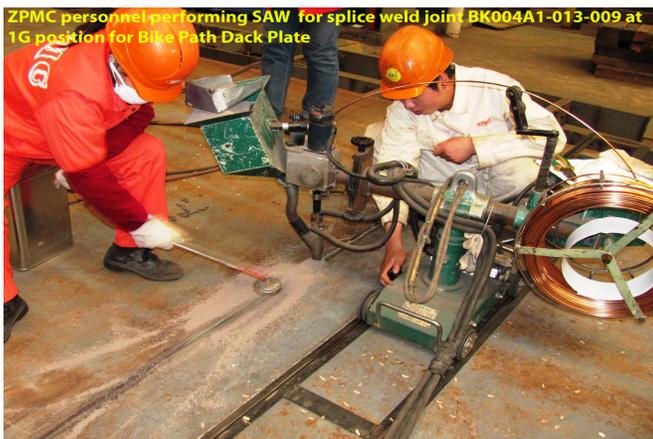
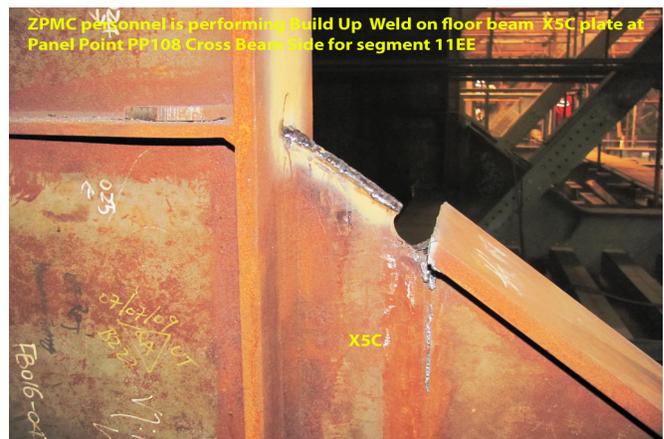
FCAW in the 3F position for the OBG Segment 12CE, weld No. SEG3003P-013. The welder is identified as #050242. ZPMC QC is identified as Mr. Guo Xing Hai. The welding variables recorded by QC appear to comply with WPS-B-T-2133.

SAW in the 1G position for the OBG Bike Path ,weld No.BK004A1-013-009. The welder is identified as #062816. ZPMC QC is identified as Mr. Zhou Chang. The welding variables recorded by QC appear to comply with WPS-B-T-2221-B-L2c-S-2.

This QA Inspector performed Ultrasonic testing (UT) 10% of the area previously tested and accepted by ZPMC Quality control personnel. This QA inspector generated a (UT) report for this date. The members are identified as OBG X37 plates for segments.
