Quality Assurance and Source Inspection

Contract #: 04-0120F4Cty: SF/ALA Rte: 80 PM: 13.2/13.9File #: 69.28**WELDING INSPECTION REPORT****Resident Engineer:** Pursell, Gary**Address:** 333 Burma Road**City:** Oakland, CA 94607**Report No:** WIR-014245**Date Inspected:** 05-Apr-2010**Project Name:** SAS Superstructure**OSM Arrival Time:** 700**Prime Contractor:** American Bridge/Fluor Enterprises, a JV**OSM Departure Time:** 1900**Contractor:** Zhenhua Port Machinery Company, Ltd (ZPMC), Changxing Island **Location:** Shanghai, China

BAY-1 -TRAVELER RAIL (TR)

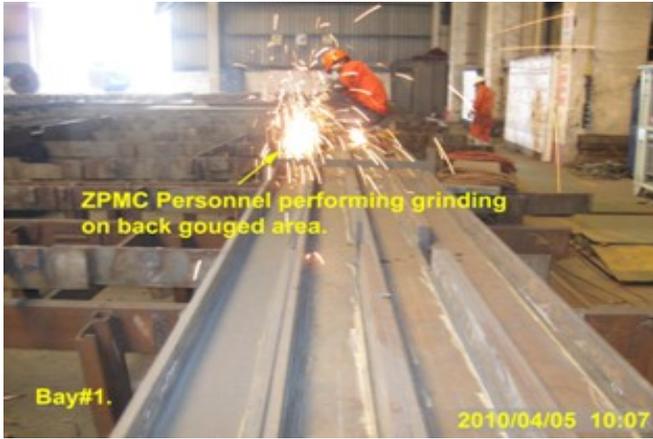
This QA Inspector observed ZPMC Personnel's performing grinding for the TR weld back gouged area. The TR Numbers are review as 20TR1-037~040.

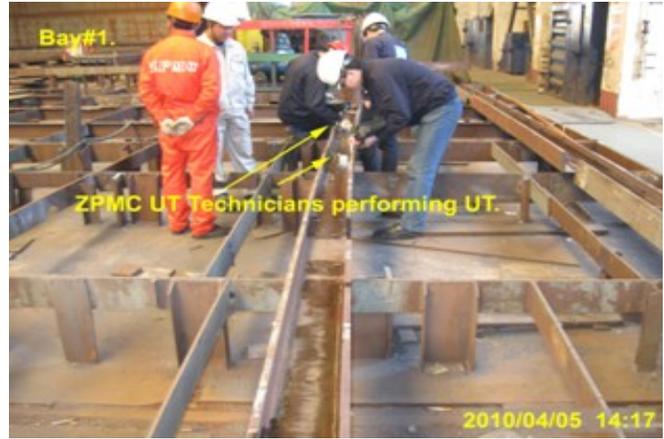
This QA Inspector observed ZPMC Ultrasonic Testing (UT) Technicians performing UT for the TR No: 20TR1-018.
