DEPARTMENT OF TRANSPORTATION

Quality Assurance and Source Inspection

Contract #: 04-0120F4Cty: SF/ALA Rte: 80 PM: 13.2/13.9File #: 69.28**WELDING INSPECTION REPORT****Resident Engineer:** Pursell, Gary**Address:** 333 Burma Road**City:** Oakland, CA 94607**Report No:** WIR-014879**Date Inspected:** 26-Apr-2010**Project Name:** SAS Superstructure**OSM Arrival Time:** 645**Prime Contractor:** American Bridge/Fluor Enterprises, a JV**OSM Departure Time:** 1845**Contractor:** Zhenhua Port Machinery Company, Ltd (ZPMC), Changxing Island **Location:** Shanghai, China

Assembly, Bay 14, 12AE, Corner Assembly, Deck plate to Edge plate.

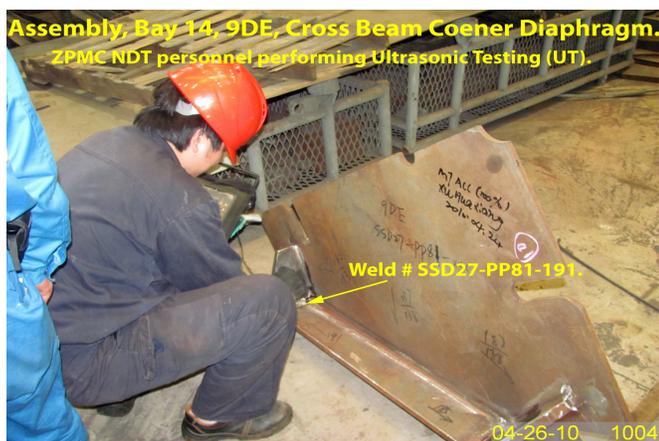
During the Quality Assurance (QA) random in-process visual inspection, this QA inspector observed ZPMC Personnel performing Ultrasonic Testing (UT) of Cross Beam Corner Diaphragm identified as SSD27-PP81-191. The attached photographs provide additional detail.
