DEPARTMENT OF TRANSPORTATION

Quality Assurance and Source Inspection

Contract #: 04-0120F4Cty: SF/ALA Rte: 80 PM: 13.2/13.9File #: 69.28**WELDING INSPECTION REPORT****Resident Engineer:** Pursell, Gary**Address:** 333 Burma Road**City:** Oakland, CA 94607**Report No:** WIR-014128**Date Inspected:** 05-May-2010**Project Name:** SAS Superstructure**OSM Arrival Time:** 700**Prime Contractor:** American Bridge/Fluor Enterprises, a JV**OSM Departure Time:** 1900**Contractor:** Zhenhua Port Machinery Company, Ltd (ZPMC), Changxing Island **Location:** Shanghai, China**CWI Name:** Li Lin**CWI Present:** Yes No**Inspected CWI report:** Yes No N/A**Rod Oven in Use:** Yes No N/A**Electrode to specification:** Yes No N/A**Weld Procedures Followed:** Yes No N/A**Qualified Welders:** Yes No N/A**Verified Joint Fit-up:** Yes No N/A**Approved Drawings:** Yes No N/A**Approved WPS:** Yes No N/A**Delayed / Cancelled:** Yes No N/A**Bridge No:** 34-0006**Component:** Tower Components**Summary of Items Observed:**

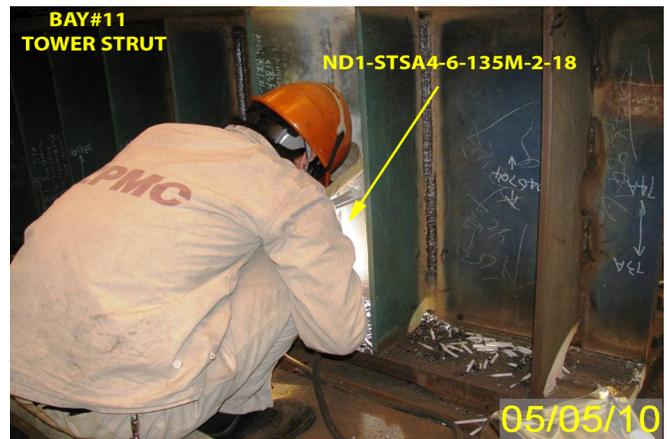
Weld joint # 083 located on Tower Strut ED1 – STSA4 – 6 – 139M – 1. Welder is identified as 046769. ZPMC Quality Control (QC) Inspector is identified as Xu Jin long. The welding variables recorded by QC appeared to comply with the WPS – B – T – 2113. (See attached photo)
