Contract #: 04-0120F4Cty: SF/ALA Rte: 80 PM: 13.2/13.9File #: 69.28**WELDING INSPECTION REPORT****Resident Engineer:** Pursell, Gary**Address:** 333 Burma Road**City:** Oakland, CA 94607**Report No:** WIR-014148**Date Inspected:** 09-May-2010**Project Name:** SAS Superstructure**OSM Arrival Time:** 700**Prime Contractor:** American Bridge/Fluor Enterprises, a JV**OSM Departure Time:** 1900**Contractor:** Zhenhua Port Machinery Company, Ltd (ZPMC), Changxing Island **Location:** Shanghai, China**CWI Name:** Mr. Qiu Wen**CWI Present:** Yes No**Inspected CWI report:** Yes No N/A**Rod Oven in Use:** Yes No N/A**Electrode to specification:** Yes No N/A**Weld Procedures Followed:** Yes No N/A**Qualified Welders:** Yes No N/A**Verified Joint Fit-up:** Yes No N/A**Approved Drawings:** Yes No N/A**Approved WPS:** Yes No N/A**Delayed / Cancelled:** Yes No N/A**Bridge No:** 34-0006**Component:** Tower**Summary of Items Observed:**

WELDING INSPECTION REPORT

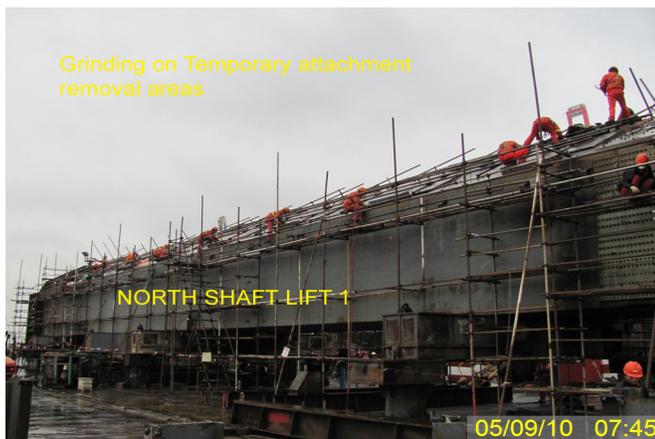
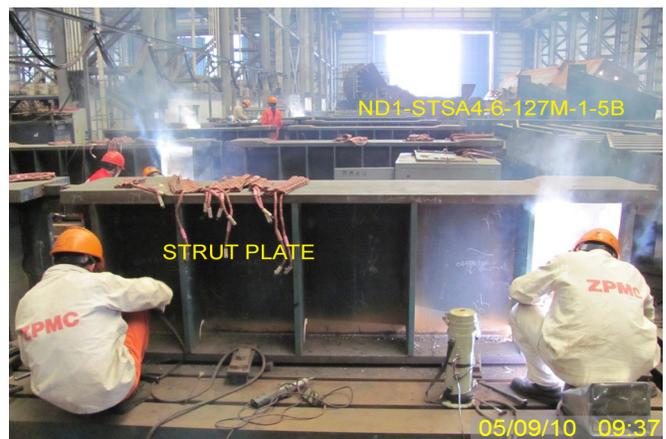
Unless otherwise noted, all work observed on this date appeared to generally comply with the applicable contract documents.
