Quality Assurance and Source Inspection

Contract #: 04-0120F4Cty: SF/ALA Rte: 80 PM: 13.2/13.9File #: 69.28**WELDING INSPECTION REPORT****Resident Engineer:** Pursell, Gary**Address:** 333 Burma Road**City:** Oakland, CA 94607**Report No:** WIR-014184**Date Inspected:** 06-May-2010**Project Name:** SAS Superstructure**OSM Arrival Time:** 700**Prime Contractor:** American Bridge/Fluor Enterprises, a JV**OSM Departure Time:** 1900**Contractor:** Zhenhua Port Machinery Company, Ltd (ZPMC), Changxing Island **Location:** Shanghai, China**CWI Name:** Chen Xi.**CWI Present:** Yes No**Inspected CWI report:** Yes No N/A**Rod Oven in Use:** Yes No N/A**Electrode to specification:** Yes No N/A**Weld Procedures Followed:** Yes No N/A**Qualified Welders:** Yes No N/A**Verified Joint Fit-up:** Yes No N/A**Approved Drawings:** Yes No N/A**Approved WPS:** Yes No N/A**Delayed / Cancelled:** Yes No N/A**Bridge No:** 34-0006**Component:** OBG**Summary of Items Observed:**

WELDING INSPECTION REPORT

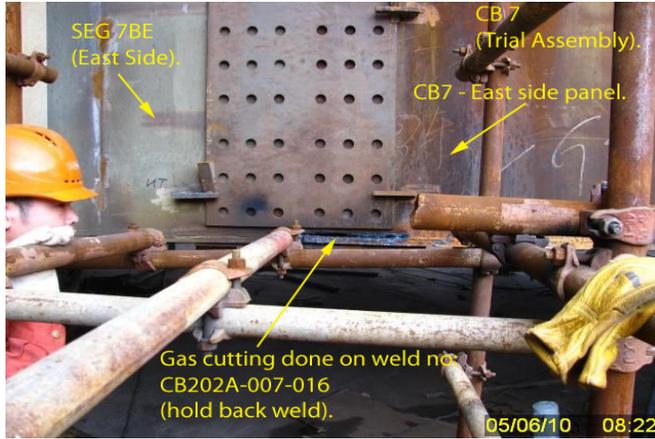
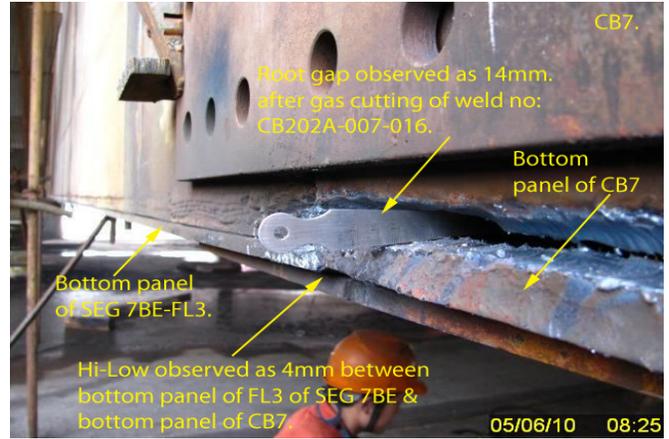
This QA Inspector observed ZPMC personnel performing gas cutting of weld joint no: CB202A-007-016 (hold back weld). Cutting of this weld is done to adjust the misalignment (hi-lo) of the bottom panel of CB7 with the bottom panel of the FL3 of SEG 7BE. This misalignment was observed as 4mm. However, after the cutting of this weld, root opening was measured and was observed as 14mm. This QA Inspector discussed this with ZPMC CWI, identified as Wu Zhi Cheng. ZPMC QC informed that they will submit CWR before this joint is re-welded. Refer attached photos for reference.

For CB7, this QA Inspector discussed with ZPMC CWI, identified as Wu Zhi Cheng, to submit CWR for weld joint no: CB202A-007-016 (hold back weld), before it is rewelded.
