**DEPARTMENT OF TRANSPORTATION**

Contract #: 04-0120F4Cty: SF/ALA Rte: 80 PM: 13.2/13.9File #: 69.28**WELDING INSPECTION REPORT****Resident Engineer:** Pursell, Gary**Address:** 333 Burma Road**City:** Oakland, CA 94607**Report No:** WIR-014233**Date Inspected:** 19-May-2010**Project Name:** SAS Superstructure**OSM Arrival Time:** 700**Prime Contractor:** American Bridge/Fluor Enterprises, a JV**OSM Departure Time:** 1900**Contractor:** Zhenhua Port Machinery Company, Ltd (ZPMC), Changxing Island **Location:** Shanghai, China**CWI Name:** Guo Yenfei**CWI Present:** Yes No**Inspected CWI report:** Yes No N/A**Rod Oven in Use:** Yes No N/A**Electrode to specification:** Yes No N/A**Weld Procedures Followed:** Yes No N/A**Qualified Welders:** Yes No N/A**Verified Joint Fit-up:** Yes No N/A**Approved Drawings:** Yes No N/A**Approved WPS:** Yes No N/A**Delayed / Cancelled:** Yes No N/A**Bridge No:** 34-0006**Component:** Bay 9**Summary of Items Observed:**

# WELDING INSPECTION REPORT

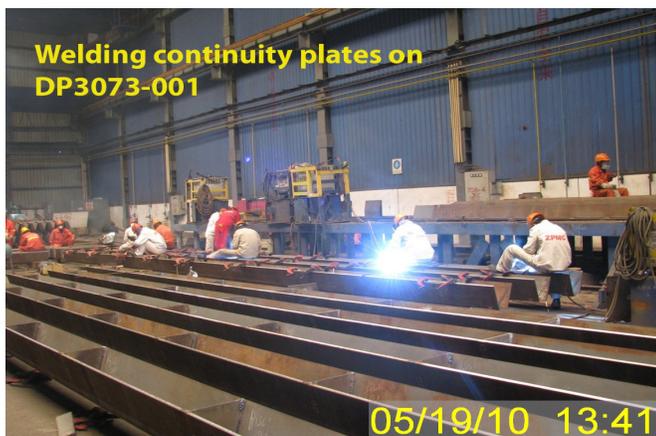
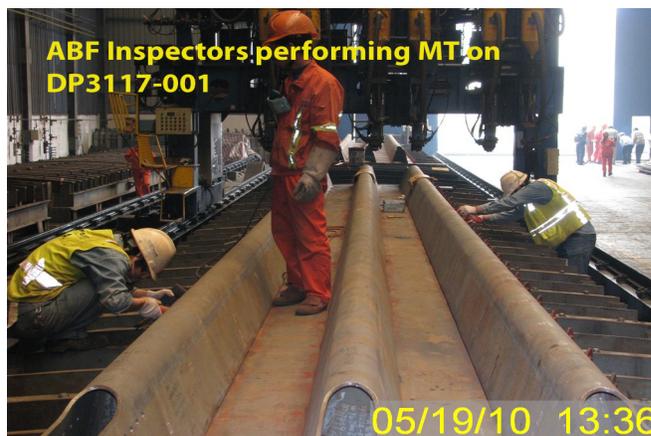
This QA Inspector observed ZPMC welding personals identified as 059440 and 059366 performing Gas Metal Arc welding (GMAW) tack welding on DP3124 (PL3320A) deck plate to U-rib. ZPMC QC is identified as Zhu Zhong Jie. The welding variables recorded by QC appeared to comply with the WPS-345-B-T-2342 U5b (U-Rib).

Observed ABF Inspectors performing Magnetic Particle Testing (MT) of tack welds of Deck plate to U-rib on DP3117-001 and DP3125-001, cracked tacks were marked for repair by ABF Inspectors.
