DEPARTMENT OF TRANSPORTATION

Contract #: 04-0120F4Cty: SF/ALA Rte: 80 PM: 13.2/13.9File #: 69.28**WELDING INSPECTION REPORT****Resident Engineer:** Pursell, Gary**Address:** 333 Burma Road**City:** Oakland, CA 94607**Report No:** WIR-014279**Date Inspected:** 08-May-2010**Project Name:** SAS Superstructure**OSM Arrival Time:** 700**Prime Contractor:** American Bridge/Fluor Enterprises, a JV**OSM Departure Time:** 1900**Contractor:** Zhenhua Port Machinery Company, Ltd (ZPMC), Changxing Island **Location:** Shanghai, China**CWI Name:** LI Yang**CWI Present:** Yes No**Inspected CWI report:** Yes No N/A**Rod Oven in Use:** Yes No N/A**Electrode to specification:** Yes No N/A**Weld Procedures Followed:** Yes No N/A**Qualified Welders:** Yes No N/A**Verified Joint Fit-up:** Yes No N/A**Approved Drawings:** Yes No N/A**Approved WPS:** Yes No N/A**Delayed / Cancelled:** Yes No N/A**Bridge No:** 34-0006**Component:** Orthotropic Box Girder (OBG)**Summary of Items Observed:**

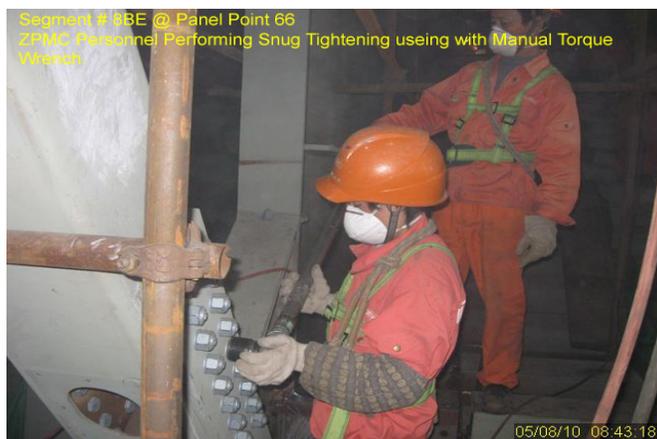
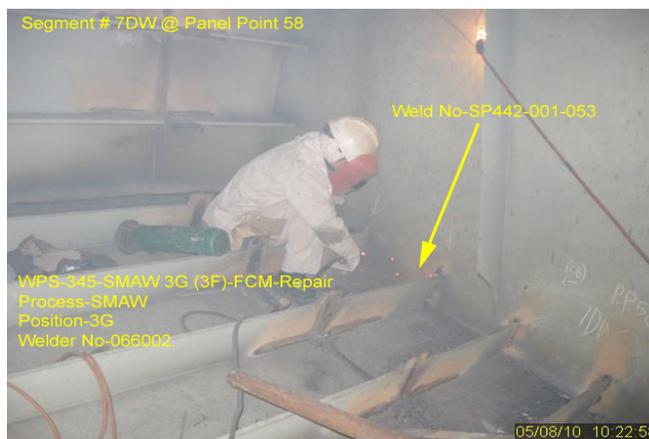
This Quality Assurance (QA) Inspector witnessed final tension verification for Upper and Lower Chevron (North and South side) at Panel Point (PP) 65, PP 66 and PP 67 for Segment 8BE. Inspected 10% on a random basis and found the tension to be in general compliance. Inspection was performed against the Notification No. 00344 Dated May 8, 2010

Bolt sizes used were M22 x 70 RC Set# DHGM220004 and final torque required was 453 N-m.

Bolt sizes used were M22 x 75 RC Set# DHGM220005 and final torque required was 475 N-m.

Bolt sizes used were M22 x 80 RC Set# DHGM220006 and final torque required was 440 N-m.

Manual Torque wrench was been used with Sr. No. XQ2-114. Please refer the pictures for more comprehensive detail.
