**DEPARTMENT OF TRANSPORTATION**

Contract #: 04-0120F4Cty: SF/ALA Rte: 80 PM: 13.2/13.9File #: 69.28**WELDING INSPECTION REPORT****Resident Engineer:** Pursell, Gary**Address:** 333 Burma Road**City:** Oakland, CA 94607**Report No:** WIR-014442**Date Inspected:** 15-May-2010**Project Name:** SAS Superstructure**OSM Arrival Time:** 700**Prime Contractor:** American Bridge/Fluor Enterprises, a JV**OSM Departure Time:** 1900**Contractor:** Zhenhua Port Machinery Company, Ltd (ZPMC), Changxing Island **Location:** Shanghai, China

# WELDING INSPECTION REPORT

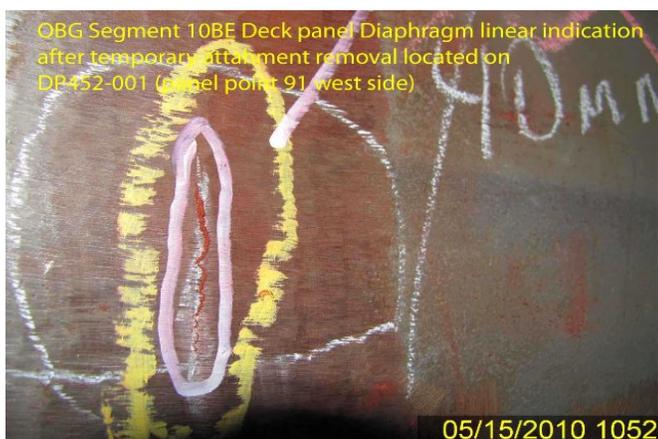
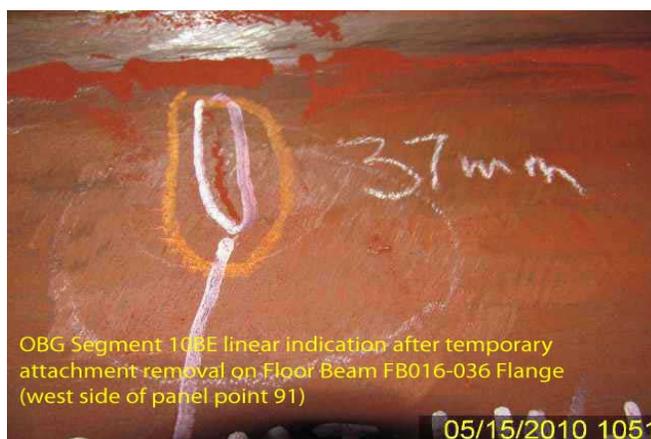
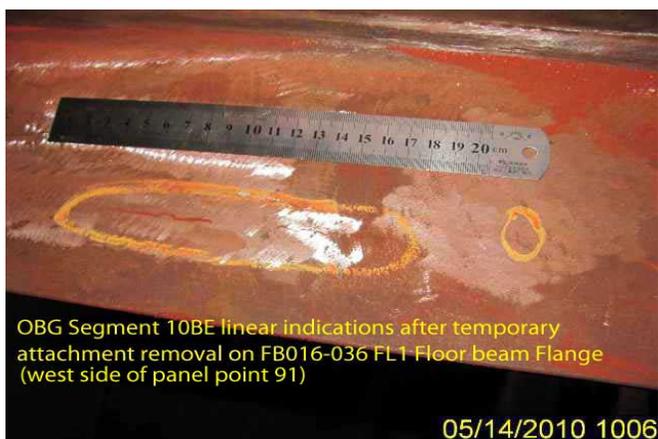
During MT inspection of deck panel diaphragm to FL1 and FL2-1 Floor beam flange weld SSD19-PP91-005 (west side of panel point 91) Caltrans QA discovered MT indications on areas where temporary attachments had been removed. These areas were shown to ZPMC QC. ZPMC stated that Critical Weld Repair report will be submitted for engineering approval. See attached photos below of base metal indications.
