Quality Assurance and Source Inspection

Contract #: 04-0120F4Cty: SF/ALA Rte: 80 PM: 13.2/13.9File #: 69.28**WELDING INSPECTION REPORT****Resident Engineer:** Pursell, Gary**Address:** 333 Burma Road**City:** Oakland, CA 94607**Report No:** WIR-014524**Date Inspected:** 31-May-2010**Project Name:** SAS Superstructure**OSM Arrival Time:** 700**Prime Contractor:** American Bridge/Fluor Enterprises, a JV**OSM Departure Time:** 1900**Contractor:** Zhenhua Port Machinery Company, Ltd (ZPMC), Changxing Island **Location:** Shanghai, China**CWI Name:** Mr. Huang Min**CWI Present:** Yes No**Inspected CWI report:** Yes No N/A**Rod Oven in Use:** Yes No N/A**Electrode to specification:** Yes No N/A**Weld Procedures Followed:** Yes No N/A**Qualified Welders:** Yes No N/A**Verified Joint Fit-up:** Yes No N/A**Approved Drawings:** Yes No N/A**Approved WPS:** Yes No N/A**Delayed / Cancelled:** Yes No N/A**Bridge No:** 34-0006**Component:** Orthotropic Box Girder (OBG)**Summary of Items Observed:**

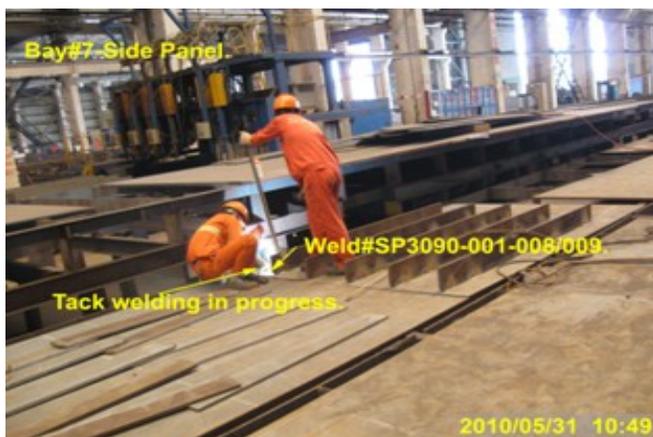
Shielded Metal Arc Welding (SMAW) Tack welding on Side panel weld joint SP3090-001-008/009. Welder is identified as 203204. ZPMC Quality Control (QC) is identified as Mr. Wang Li Yang. The welding variables appeared to comply with the Applicable WPS: WPS-B-P-2112.

Refer attached photos for reference.

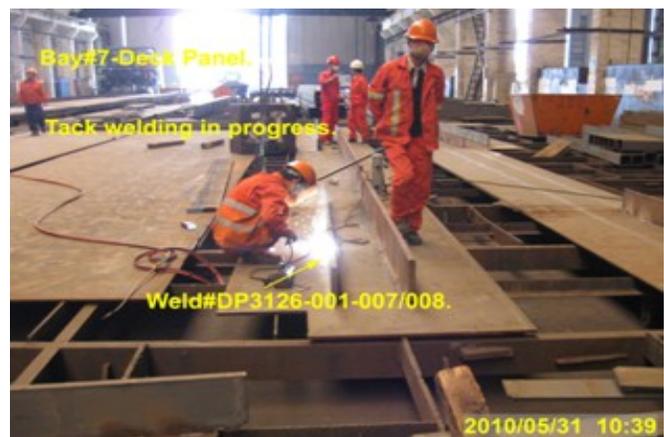
SMAW Tack welding on Deck panel weld joint DP3126-001-007/008. Welder is identified as 250833. ZPMC Quality Control (QC) is identified as Mr. Wang Li Yang. The welding variables appeared to comply with the Applicable WPS: WPS-B-T-4112-4.

Refer attached photos for reference.
