DEPARTMENT OF TRANSPORTATION

Quality Assurance and Source Inspection

Contract #: 04-0120F4Cty: SF/ALA Rte: 80 PM: 13.2/13.9File #: 69.28**WELDING INSPECTION REPORT****Resident Engineer:** Pursell, Gary**Address:** 333 Burma Road**City:** Oakland, CA 94607**Report No:** WIR-014638**Date Inspected:** 10-Jun-2010**Project Name:** SAS Superstructure**OSM Arrival Time:** 700**Prime Contractor:** American Bridge/Fluor Enterprises, a JV**OSM Departure Time:** 1900**Contractor:** Zhenhua Port Machinery Company, Ltd (ZPMC), Changxing Island **Location:** Shanghai, China

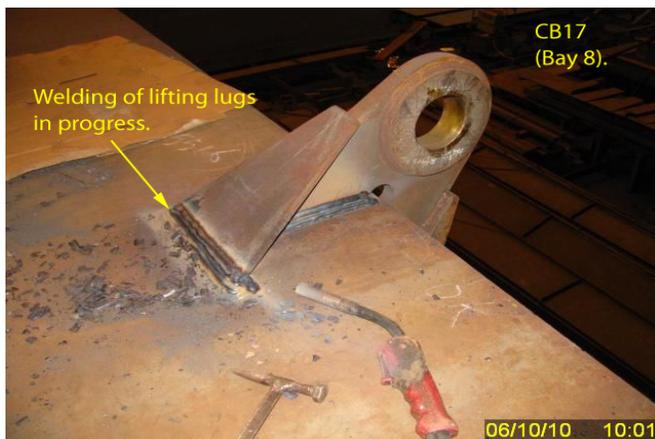
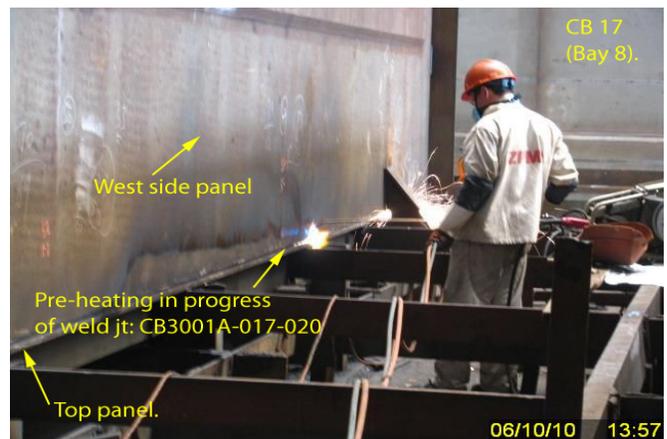
Flux Cored Arc Welding (FCAW) of weld joints CB3001A-017-020. Welder is identified as 054460. ZPMC QC is identified as Feng Ya Jun. The welding variables recorded by QC appeared to comply with the Applicable WPS: WPS-B-T-2232-TC-U4b-F.

FCAW of lifting lugs with Bottom panel. Welder is identified as 054460. ZPMC QC is identified as Feng Ya Jun. The welding variables recorded by QC appeared to comply with the Applicable WPS: WPS-B-T-2231-B-U2-F.
