Contract #: 04-0120F4Cty: SF/ALA Rte: 80 PM: 13.2/13.9File #: 69.28**WELDING INSPECTION REPORT****Resident Engineer:** Pursell, Gary**Address:** 333 Burma Road**City:** Oakland, CA 94607**Report No:** WIR-014776**Date Inspected:** 14-Jun-2010**Project Name:** SAS Superstructure**OSM Arrival Time:** 700**Prime Contractor:** American Bridge/Fluor Enterprises, a JV**OSM Departure Time:** 1900**Contractor:** Zhenhua Port Machinery Company, Ltd (ZPMC), Changxing Island **Location:** Shanghai, China**CWI Name:** Yang Bai Qiang**CWI Present:** Yes No**Inspected CWI report:** Yes No N/A**Rod Oven in Use:** Yes No N/A**Electrode to specification:** Yes No N/A**Weld Procedures Followed:** Yes No N/A**Qualified Welders:** Yes No N/A**Verified Joint Fit-up:** Yes No N/A**Approved Drawings:** Yes No N/A**Approved WPS:** Yes No N/A**Delayed / Cancelled:** Yes No N/A**Bridge No:** 34-0006**Component:** OBG**Summary of Items Observed:**

OBG Bay 09, Deck Panel 13CW-DP3144-001

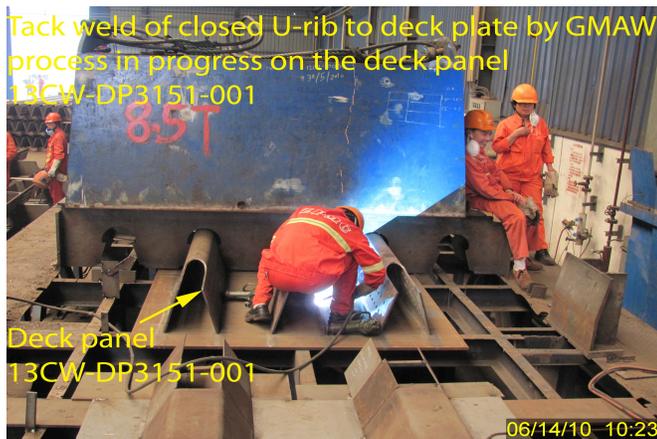
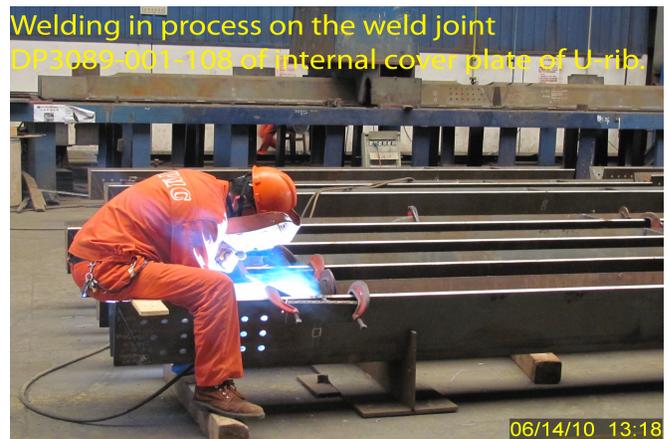
During random in process inspection this QA Inspector observed tack welding of closed U-rib to deck plate by GMAW process in progress on the weld joints of deck panel 13CW-DP3151-001. Welder is identified as 062305. ZPMC CWI is identified as Mr. Yang Bai Qiang. The welding variables recorded by QC appeared to comply with WPS-B-T-2342-U5(Urib).
