Quality Assurance and Source Inspection

Contract #: 04-0120F4Cty: SF/ALA Rte: 80 PM: 13.2/13.9File #: 69.28**WELDING INSPECTION REPORT****Resident Engineer:** Pursell, Gary**Address:** 333 Burma Road**City:** Oakland, CA 94607**Report No:** WIR-014810**Date Inspected:** 10-Jun-2010**Project Name:** SAS Superstructure**OSM Arrival Time:** 700**Prime Contractor:** American Bridge/Fluor Enterprises, a JV**OSM Departure Time:** 1900**Contractor:** Zhenhua Port Machinery Company, Ltd (ZPMC), Changxing Island **Location:** Shanghai, China**CWI Name:** Li Yang**CWI Present:** Yes No**Inspected CWI report:** Yes No N/A**Rod Oven in Use:** Yes No N/A**Electrode to specification:** Yes No N/A**Weld Procedures Followed:** Yes No N/A**Qualified Welders:** Yes No N/A**Verified Joint Fit-up:** Yes No N/A**Approved Drawings:** Yes No N/A**Approved WPS:** Yes No N/A**Delayed / Cancelled:** Yes No N/A**Bridge No:** 34-0006**Component:** OBG**Summary of Items Observed:**

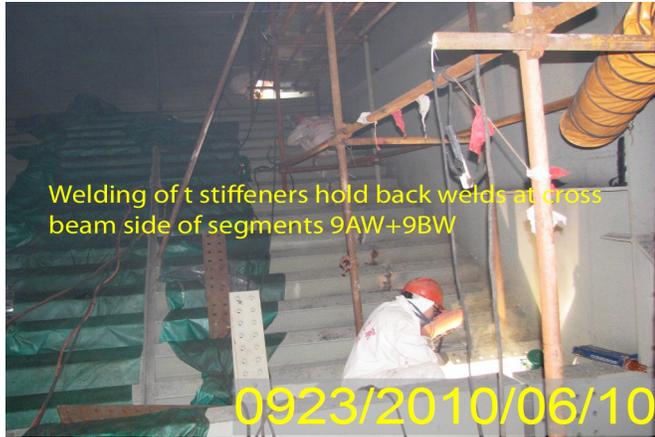
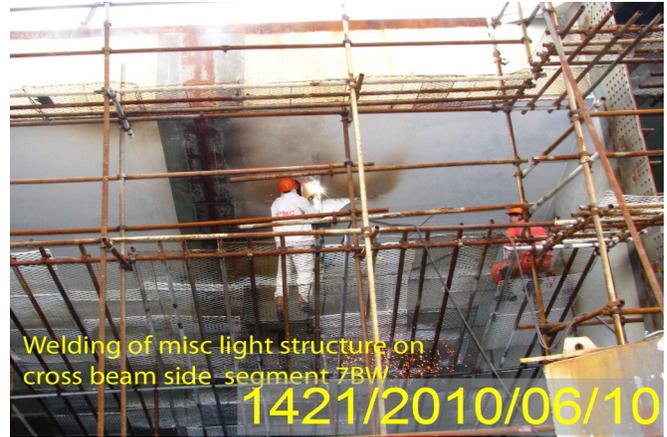
Shield Metal Arc Welding (SMAW) repair welding was performed on weld joint 003 located at OBW8A deck plate splice of segment. Welder is identified as Mr. Ni Leijiang (045240). ZPMC QC is identified as Li Yang. The welding variables monitored and recorded by the QC appeared to comply with WPS-345-SMAW-4G (4F)-FCM-Repair-1 and CWR1612 procedure.

Shield Metal Arc Welding (SMAW) repair welding was performed on weld joint 016 and 017 located at SEG430 cross beam side of segment. Welder is identified as Mr. Zhao Guanglin (044779). ZPMC QC is identified as Li Yang. The welding variables monitored and recorded by the QC appeared to comply with WPS-345-SMAW-4G (4F)-FCM-Repair-1 and WR13262 procedure.
