DEPARTMENT OF TRANSPORTATION

Contract #: 04-0120F4Cty: SF/ALA Rte: 80 PM: 13.2/13.9File #: 69.28**WELDING INSPECTION REPORT****Resident Engineer:** Pursell, Gary**Address:** 333 Burma Road**City:** Oakland, CA 94607**Report No:** WIR-014871**Date Inspected:** 10-Jun-2010**Project Name:** SAS Superstructure**OSM Arrival Time:** 1900**Prime Contractor:** American Bridge/Fluor Enterprises, a JV**OSM Departure Time:** 700**Contractor:** Zhenhua Port Machinery Company, Ltd (ZPMC), Changxing Island **Location:** Shanghai, China**CWI Name:** See Below**CWI Present:** Yes No**Inspected CWI report:** Yes No N/A**Rod Oven in Use:** Yes No N/A**Electrode to specification:** Yes No N/A**Weld Procedures Followed:** Yes No N/A**Qualified Welders:** Yes No N/A**Verified Joint Fit-up:** Yes No N/A**Approved Drawings:** Yes No N/A**Approved WPS:** Yes No N/A**Delayed / Cancelled:** Yes No N/A**Bridge No:** 34-0006**Component:** OBG**Summary of Items Observed:**

OBG Segment Trial Assembly

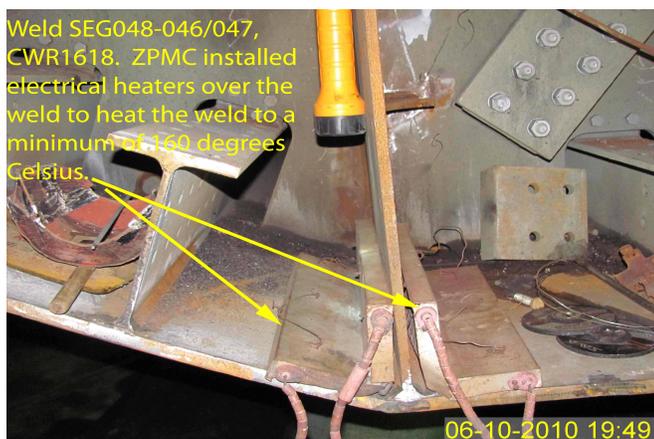
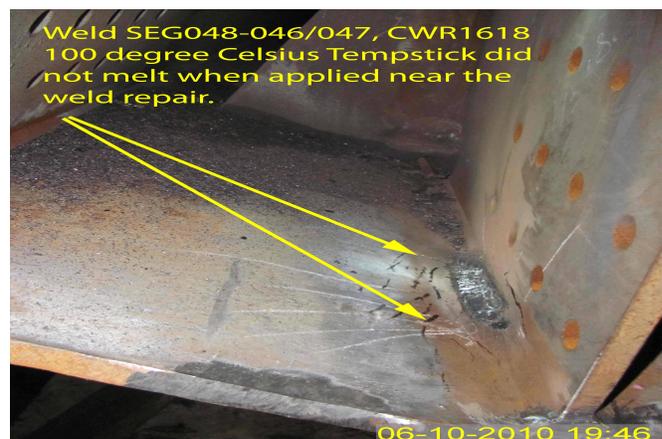
This QA Inspector observed ZPMC welder Mr. Chen Zheng Hua, stencil 220067 is using shielded metal arc procedure WPS-345-SMAW-1G(1F)-Repair-1 to make longitudinal diaphragm weld repairs SEG048-046 and SEG048-047 on segment 8CE. These longitudinal diaphragm welds had been identified as having rejections and weld repair document B-CWR1618 was issued to make these repairs. This QA Inspector measured a welding current of approximately 170 amps and Mr. Chen Zheng Hua appears to be certified to make this weld. The weld repair document requires the base material be preheated to a minimum of 160 degrees Celsius prior to welding and that the 160 degrees Celsius temperature be maintained throughout the welding process. After the welding is complete the weld temperature is to be held to a minimum of 160 degrees Celsius for a period of time then reduced in a controlled manner. This QA Inspector observed ZPMC QC used a 100 degree Celsius temperature indicating crayon to monitor the base material temperature and it appears that the base material near one end of the weld is below 100 degree Celsius and the CWR requires a minimum base material temperature of degrees Celsius. ZPMC QC and CWI Inspector Mr. Gu Rong Jian explained to this QA Inspector that the base material near the weld had cooled as the weld was being ground and that they will reinstall electric heaters on the weld and keep it at a minimum of 160 degrees Celsius. Items observed on this date do not fully appear to comply with applicable contract documents. See the photographs below for additional information.
