Contract #: 04-0120F4Cty: SF/ALA Rte: 80 PM: 13.2/13.9File #: 69.28**WELDING INSPECTION REPORT****Resident Engineer:** Pursell, Gary**Address:** 333 Burma Road**City:** Oakland, CA 94607**Report No:** WIR-014961**Date Inspected:** 03-Jun-2010**Project Name:** SAS Superstructure**OSM Arrival Time:** 700**Prime Contractor:** American Bridge/Fluor Enterprises, a JV**OSM Departure Time:** 1900**Contractor:** Zhenhua Port Machinery Company, Ltd (ZPMC), Changxing Island **Location:** Shanghai, China

# WELDING INSPECTION REPORT

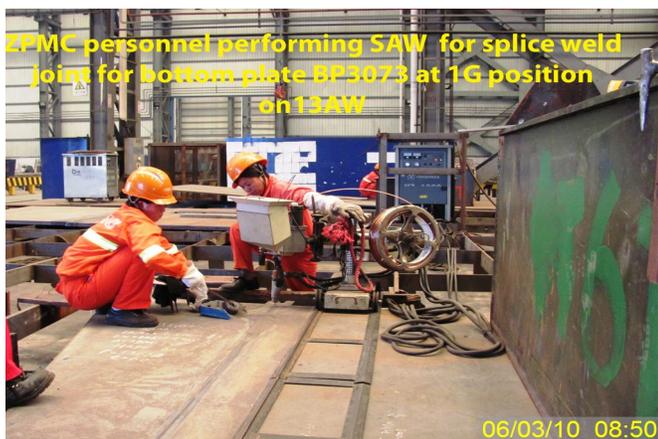
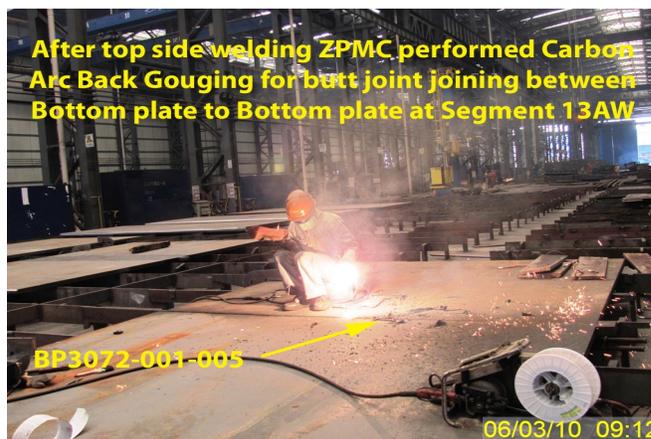
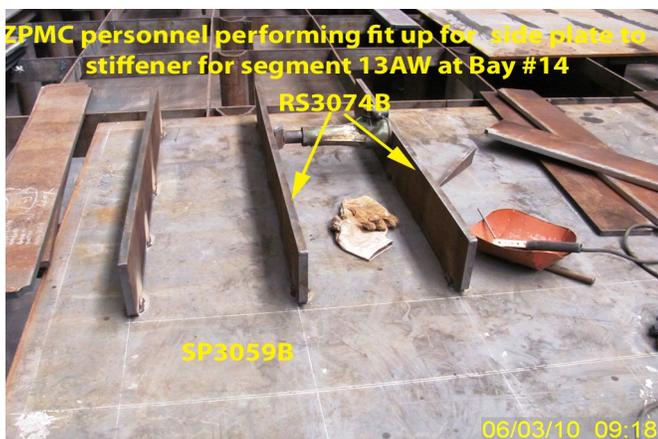
SAW in the 1G position for the OBG Segment 13AW bottom Plate, weld No. BP3073-001-001. The welder is identified as #045265. ZPMC QC is identified as Mr. Li Ming Yang. The welding variables recorded by QC appear to comply with WPS-B-T-2221-B-U3c-S-2.

During visual inspection at Bay#16 the QA Inspector observed that ZPMC personal performing heat straightening at bottom plate weld BP3073-001-001 for segment 13AW. The heat straightening report find as HSR-8569.

During visual inspection at Bay#14 the QA Inspector observed that ZPMC personal performing fit up at Side plat SP3059B to Stiffener RS3074B for segment 13AE.

During visual inspection at Bay#14 the QA Inspector observed that ZPMC personal performing fit up at Side plat SP3091B to Stiffener RS3075B for segment 13AW.
